# Access Compliance Report

## Public Rights-of-Way

### (Curb Ramps)

Intersection ID: N/A	Main Street: RICHFIELD_LN	Cross Street: N/A	Location: N
ADA ID: 7DE363FCD9DE	Ramp Type: Perp	Initial Pass/Fail: Fail	Overall Compliance: No
		Severity Score: 12.5

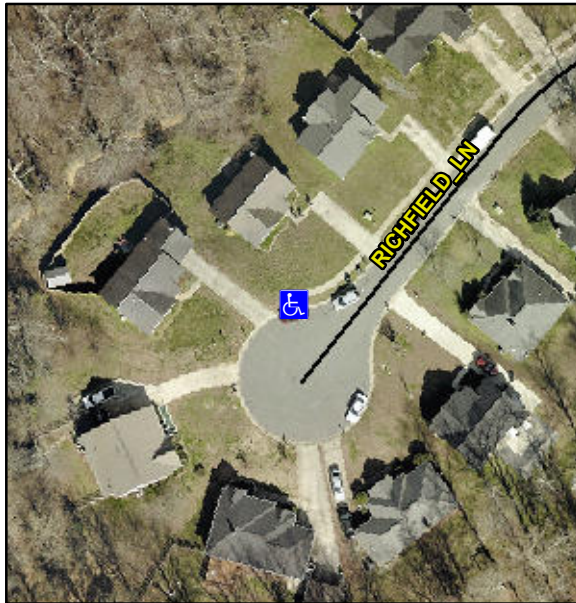
**Not Found, R304.2.2**

Compliance	Description	Data	Compliance	Description	Data
N/A	Ramp Length (in)	<b>48.0</b>	No	Ramp Slope (%)	<b>9.9</b>
Yes	Ramp Width (in)	<b>48.0</b>	Yes	Ramp XSlope (%)	<b>2.0</b>
N/A	Flare Type LT	<b>N/A</b>	N/A	Flare Type RT	<b>N/A</b>
N/A	Flare Slope LT (%)	<b>N/A</b>	N/A	Flare Slope RT (%)	<b>N/A</b>
N/A	Flare Traversable LT?	<b>N/A</b>	N/A	Flare Traversable RT?	<b>N/A</b>
N/A	Landing Length (in)	<b>N/A</b>	N/A	DWS Provided?	<b>N/A</b>
N/A	Landing Width (in)	<b>N/A</b>	N/A	DWS Contrast?	<b>N/A</b>
N/A	Landing Slope (%)	<b>N/A</b>	N/A	DWS Length (in)	<b>N/A</b>
N/A	Landing X Slope (%)	<b>N/A</b>	N/A	DWS Full Width?	<b>N/A</b>
N/A	Landing Curb? (Y/N)	<b>N/A</b>	N/A	DWS Offset (in)	<b>N/A</b>
N/A	Shared Landing?	<b>N/A</b>			
N/A	Gutter Ponding?	<b>N/A</b>	N/A	Gutter Slope (%)	<b>N/A</b>
N/A	Gutter Lip Ht (in)	<b>N/A</b>	N/A	Gutter X Slope (%)	<b>N/A</b>
N/A	Painted X Walk1?	<b>No</b>	N/A	Painted X Walk2?	<b>N/A</b>

X Walk 1 Direction	<b>To S</b>		X Walk 2 Direction	<b>N/A</b>
N/A	X Walk 1 Width (in)	<b>N/A</b>	N/A	X Walk 2 Width (in)	<b>N/A</b>
	X Walk 1 Slope (%)	<b>6.5</b>		X Walk 2 Slope (%)	<b>N/A</b>
	X Walk 1 X Slope (%)	<b>1.4</b>		X Walk 2 X Slope (%)	<b>N/A</b>
N/A	Ramp inside XWalk1?	<b>N/A</b>	N/A	Ramp inside XWalk2?	<b>N/A</b>
	Road Slope (%)	<b>N/A</b>	N/A	Clear Space?	<b>N/A</b>
	Road X Slope (%)	<b>N/A</b>	N/A	Clear Space to XWalk (in)	<b>N/A</b>
N/A	Any Obstructions?	<b>N/A</b>	N/A	Storm Grate/Utility Hazard?	<b>N/A</b>
	Obstruction Type			Storm Grate/Utility Type	
		<b>N/A</b>			<b>N/A</b>
			Yes	Surface Condition? (G/P)	<b>Good</b>

**Remove & Replace Entire Ramp.**

Total Cost: \$ **1850.00**
