# Access Compliance Report

## Public Rights-of-Way

### (Curb Ramps)

| Intersection ID: 50233 | Main Street: ORCHARD_STONE_RN | Cross Street: ARDREY_KELL_RD | Location: NE |

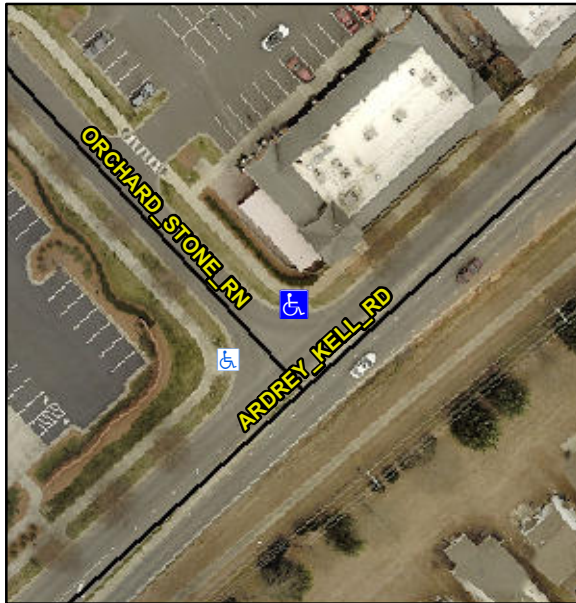
| ADA ID: 7DEE6F485C88 | Ramp Type: Perp | Initial Pass/Fail: Pass | Overall Compliance: No |
| | | Severity Score: 5 | |

| Compliance | Description | Data | Compliance | Description | Data |
|---|---|---|---|---|---|
| N/A | Flare Slope LT (%) | 3.6 | No | Flare Slope RT (%) | 13.0 |
| No | Landing Slope (%) | 3.0 | Yes | DWS Length (in) | 24.5 |

**Remove & Replace Entire Ramp.**

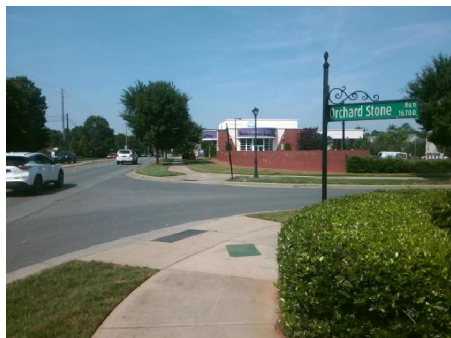
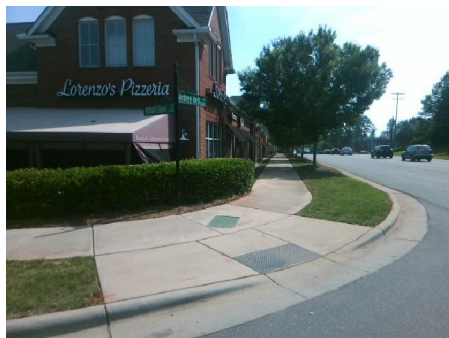
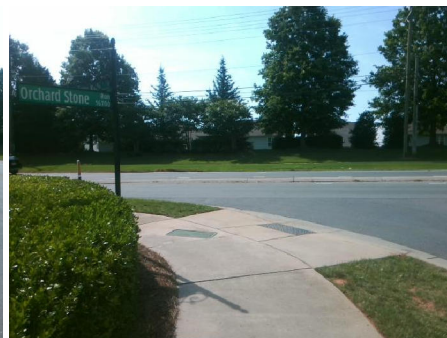
| Compliance | Description | Data | Compliance | Description | Data |
|---|---|---|---|---|---|
| | | | Yes | Surface Condition? (G/P) | Good |

Total Cost: \$ 1850.00
