# Access Compliance Report

## Public Rights-of-Way

### (Curb Ramps)

| Intersection ID: N/A | Main Street: PROVIDENCE_COUNTRY_CLUB_DR | Cross Street: SOUTHMORE_DR | Location: NE |

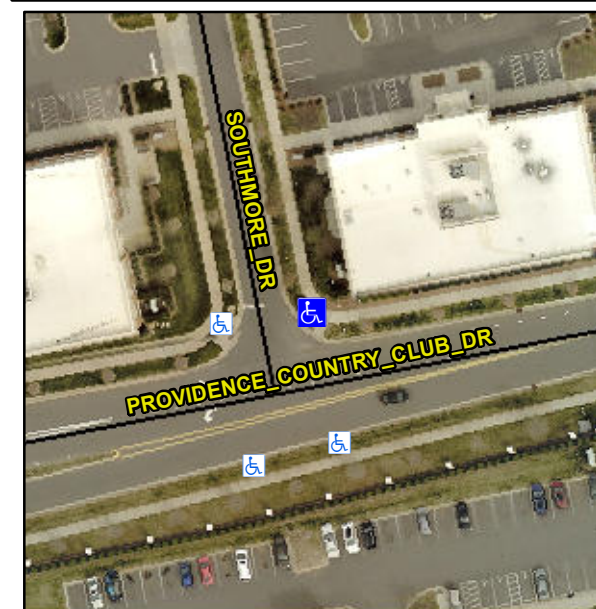
| ADA ID: 7DF8659638CB | Ramp Type: PerpDiag | Initial Pass/Fail: Fail | Overall Compliance: No |

**Not Found, R304.2.2, R304.5.3**

| Compliance | Description | Data | Compliance | Description | Data |
|---|---|---|---|---|---|
| N/A | Ramp Length (in) | 93.0 | No | Ramp Slope (%) | 8.8 |
| Yes | Ramp Width (in) | 48.0 | No | Ramp XSlope (%) | 3.8 |

**Remove & Replace Curb Ramp With Two New Directional Ramps or Equivalent.**

Total Cost: \$ 3200.00
