Access Compliance Report

Public Rights-of-Way

(Curb Ramps)

| Intersection ID: 16626 | Main Street: INDEPENDENCE_WOODS_DR | Cross Street: HOOPER_CT | Location: NE |

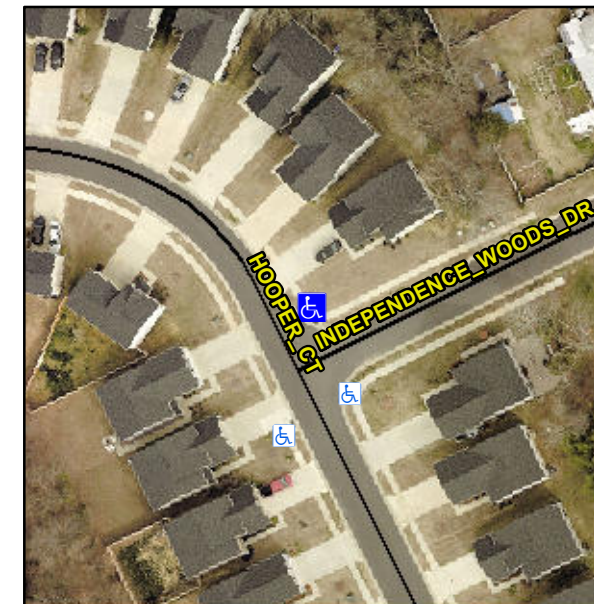
| ADA ID: 7DF906EF66AD | Ramp Type: PerpDiag | Initial Pass/Fail: Fail | Overall Compliance: No |
| | | Severity Score: 12.5 | |

Not Found, R304.2.2

| Compliance | Description | Data | Compliance | Description | Data |
|---|---|---|---|---|---|
| N/A | Ramp Length (in) | 53.0 | No | Ramp Slope (%) | 11.2 |
| Yes | Ramp Width (in) | 48.0 | Yes | Ramp XSlope (%) | 1.1 |

Remove & Replace Curb Ramp With Two New Directional Ramps or Equivalent.

Total Cost: \$ 3200.00
