Access Compliance Report

Public Rights-of-Way

(Curb Ramps)

Intersection ID: 53228	Main Street: FLEETWOOD_DR	Cross Street: MAJOR_SAMUALS_WY	Location: SW
ADA ID: 7E02AAA1CAFE	Ramp Type: Perp	Initial Pass/Fail: Fail	Overall Compliance: No
Severity Score: 21.25			
Codes/Mitigation Info/Possible Solution		Field Measurements/Component Compliance

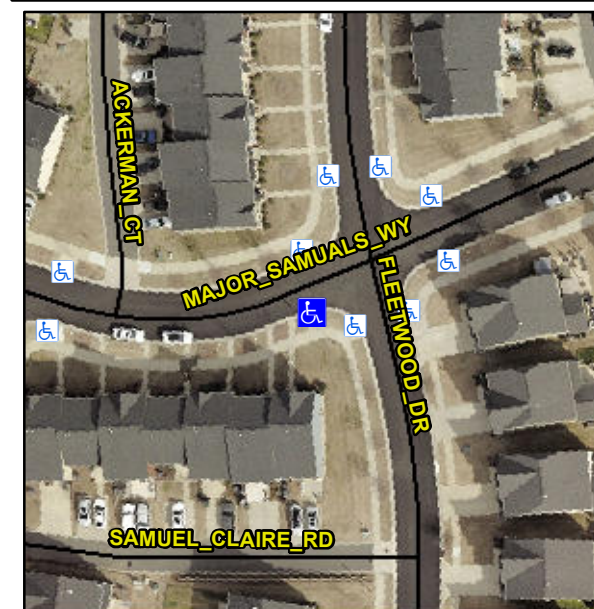
Not Found, R304.5.1, R304.2.2

Compliance	Description	Data	Compliance	Description	Data
N/A	Ramp Length (in)	90.0	No	Ramp Slope (%)	8.5
No	Ramp Width (in)	46.0	Yes	Ramp XSlope (%)	0.1
N/A	Flare Type LT	N/A	N/A	Flare Type RT	N/A
N/A	Flare Slope LT (%)	N/A	N/A	Flare Slope RT (%)	N/A
N/A	Flare Traversable LT?	N/A	N/A	Flare Traversable RT?	N/A
N/A	Landing Length (in)	N/A	N/A	DWS Provided?	N/A
N/A	Landing Width (in)	N/A	N/A	DWS Contrast?	N/A
N/A	Landing Slope (%)	N/A	N/A	DWS Length (in)	N/A
N/A	Landing X Slope (%)	N/A	N/A	DWS Full Width?	N/A
N/A	Landing Curb? (Y/N)	N/A	N/A	DWS Offset (in)	N/A
N/A	Shared Landing?	N/A			
N/A	Gutter Ponding?	N/A	N/A	Gutter Slope (%)	N/A
N/A	Gutter Lip Ht (in)	N/A	N/A	Gutter X Slope (%)	N/A
N/A	Painted X Walk1?	No	N/A	Painted X Walk2?	N/A
	X Walk 1 Direction	To N		X Walk 2 Direction	N/A
N/A	X Walk 1 Width (in)	N/A	N/A	X Walk 2 Width (in)	N/A
	X Walk 1 Slope (%)	0.7		X Walk 2 Slope (%)	N/A
	X Walk 1 X Slope (%)	0.1		X Walk 2 X Slope (%)	N/A

N/A	Ramp inside XWalk1?	N/A	N/A	Ramp inside XWalk2?	N/A
	Road Slope (%)	N/A	N/A	Clear Space?	N/A
	Road X Slope (%)	N/A	N/A	Clear Space to XWalk (in)	N/A
N/A	Any Obstructions?	N/A	N/A	Storm Grate/Utility Hazard?	N/A
	Obstruction Type			Storm Grate/Utility Type	
		N/A			N/A
			Yes	Surface Condition? (G/P)	Good

Possible Solutions:

Remove & Replace Entire Ramp.
