# Access Compliance Report

## Public Rights-of-Way

### (Curb Ramps)

Intersection ID: 12811	Main Street: SCHOOL_ST	Cross Street: THOMAS_AV	Location: NE
ADA ID: 7E06E4B031CC	Ramp Type: PerpDiag	Initial Pass/Fail: Fail	Overall Compliance: No
		Severity Score: 8.75

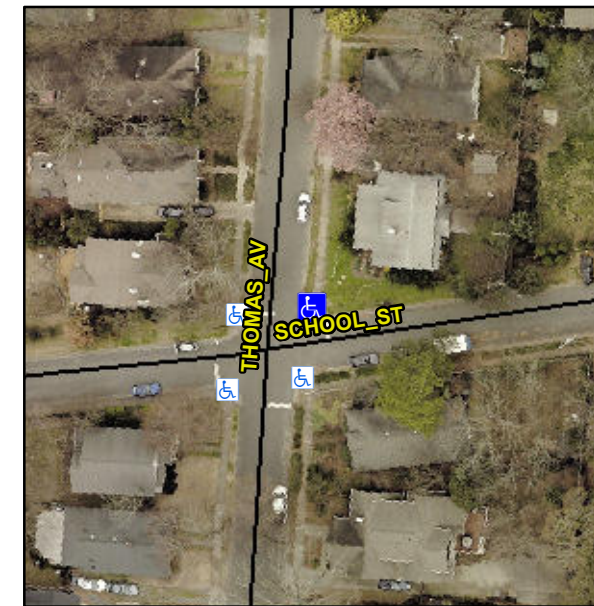
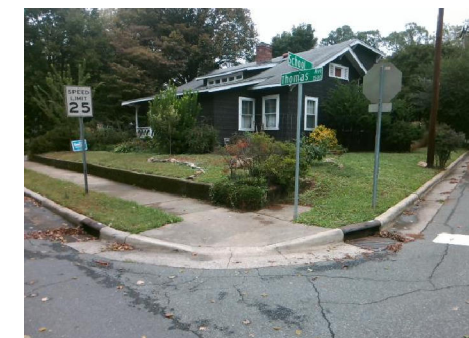
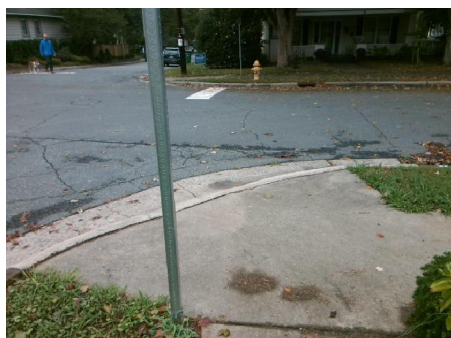
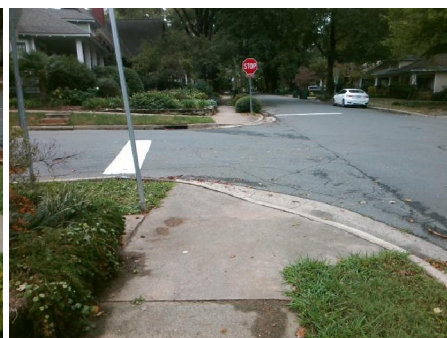
**Not Found, R304.5.1**

Compliance	Description	Data	Compliance	Description	Data
N/A	Ramp Length (in)	45.0	Yes	Ramp Slope (%)	7.0
No	Ramp Width (in)	42.0	Yes	Ramp XSlope (%)	1.8
N/A	Flare Type LT	N/A	N/A	Flare Type RT	N/A
N/A	Flare Slope LT (%)	N/A	N/A	Flare Slope RT (%)	N/A
N/A	Flare Traversable LT?	N/A	N/A	Flare Traversable RT?	N/A
N/A	Landing Length (in)	N/A	N/A	DWS Provided?	N/A
N/A	Landing Width (in)	N/A	N/A	DWS Contrast?	N/A
N/A	Landing Slope (%)	N/A	N/A	DWS Length (in)	N/A
N/A	Landing X Slope (%)	N/A	N/A	DWS Full Width?	N/A
N/A	Landing Curb? (Y/N)	N/A	N/A	DWS Offset (in)	N/A
N/A	Shared Landing?	N/A			
N/A	Gutter Ponding?	N/A	N/A	Gutter Slope (%)	N/A
N/A	Gutter Lip Ht (in)	N/A	N/A	Gutter X Slope (%)	N/A
N/A	Painted X Walk1?	No	N/A	Painted X Walk2?	No
	X Walk 1 Direction	To W		X Walk 2 Direction	To S
N/A	X Walk 1 Width (in)	N/A	N/A	X Walk 2 Width (in)	N/A
	X Walk 1 Slope (%)	2.8		X Walk 2 Slope (%)	6.2
	X Walk 1 X Slope (%)	5.3		X Walk 2 X Slope (%)	0.3

N/A	Ramp inside XWalk1?	N/A	N/A	Ramp inside XWalk2?	N/A
	Road Slope (%)	1.9	N/A	Clear Space?	N/A
	Road X Slope (%)	4.1	N/A	Clear Space to XWalk (in)	N/A
N/A	Any Obstructions?	N/A	N/A	Storm Grate/Utility Hazard?	N/A
	Obstruction Type			Storm Grate/Utility Type	
		N/A			N/A
		Yes		Surface Condition? (G/P)	Good

**Remove & Replace Curb Ramp With Two New Directional Ramps or Equivalent.**

Total Cost: \$ 3200.00
