Access Compliance Report

Public Rights-of-Way

(Curb Ramps)

Intersection ID: 10019902	Main Street: ARCO_CORPORATE_DR	Cross Street: N/A	Location: SE
ADA ID: 7E09ACE38E18	Ramp Type: PerpDiag	Initial Pass/Fail: Fail	Overall Compliance: No
Severity Score: 25			
Codes/Mitigation Info/Possible Solution		Field Measurements/Component Compliance

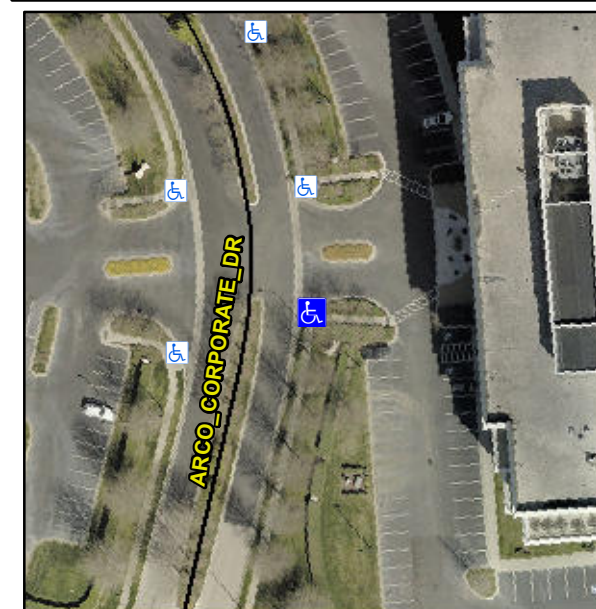
Not Found, R304.2.2

Compliance	Description	Data	Compliance	Description	Data
N/A	Ramp Length (in)	28.0	No	Ramp Slope (%)	12.5
Yes	Ramp Width (in)	48.0	Yes	Ramp XSlope (%)	0.4
N/A	Flare Type LT	N/A	N/A	Flare Type RT	N/A
N/A	Flare Slope LT (%)	N/A	N/A	Flare Slope RT (%)	N/A
N/A	Flare Traversable LT?	N/A	N/A	Flare Traversable RT?	N/A
N/A	Landing Length (in)	N/A	N/A	DWS Provided?	N/A
N/A	Landing Width (in)	N/A	N/A	DWS Contrast?	N/A
N/A	Landing Slope (%)	N/A	N/A	DWS Length (in)	N/A
N/A	Landing X Slope (%)	N/A	N/A	DWS Full Width?	N/A
N/A	Landing Curb? (Y/N)	N/A	N/A	DWS Offset (in)	N/A
N/A	Shared Landing?	N/A			
N/A	Gutter Ponding?	N/A	N/A	Gutter Slope (%)	N/A
N/A	Gutter Lip Ht (in)	N/A	N/A	Gutter X Slope (%)	N/A
N/A	Painted X Walk1?	No	N/A	Painted X Walk2?	No
	X Walk 1 Direction	To N		X Walk 2 Direction	To W
N/A	X Walk 1 Width (in)	N/A	N/A	X Walk 2 Width (in)	N/A
	X Walk 1 Slope (%)	4.4		X Walk 2 Slope (%)	3.1
	X Walk 1 X Slope (%)	6.1		X Walk 2 X Slope (%)	3.4

N/A	Ramp inside XWalk1?	N/A	N/A	Ramp inside XWalk2?	N/A
	Road Slope (%)	0.7	N/A	Clear Space?	N/A
	Road X Slope (%)	5.0	N/A	Clear Space to XWalk (in)	N/A
N/A	Any Obstructions?	N/A	N/A	Storm Grate/Utility Hazard?	N/A
	Obstruction Type			Storm Grate/Utility Type	
		N/A			N/A
			Yes	Surface Condition? (G/P)	Good

Remove & Replace Curb Ramp With Two New Directional Ramps or Equivalent.

Total Cost: \$ 3200.00
