# Access Compliance Report

## Public Rights-of-Way

### (Curb Ramps)

| Intersection ID: 8320 | Main Street: JOHNSON_RD | Cross Street: N_GRAHAM_ST | Location: NE |

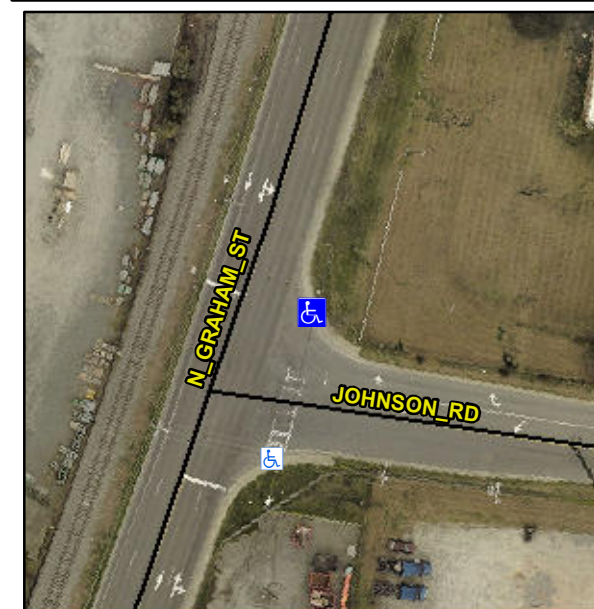
| ADA ID: 7E0C144DBFD6 | Ramp Type: Perp | Initial Pass/Fail: Fail | Overall Compliance: No |
| Severity Score: 8.75 | | | |

**Not Found, R304.5.1**

| Compliance | Description | Data | Compliance | Description | Data |
|---|---|---|---|---|---|
| No | Ramp Width (in) | 47.0 | Yes | Ramp XSlope (%) | 0.9 |
| N/A | Gutter Lip Ht (in) | 1.0 | N/A | Gutter X Slope (%) | N/A |

**Remove & Replace Entire Ramp.**

Total Cost: \$ 1850.00
