Access Compliance Report

Public Rights-of-Way

(Curb Ramps)

Intersection ID: 24596	Main Street: JARDINIERE_CT	Cross Street: SEQUOIA_RED_LN	Location: NE
ADA ID: 7E0DFFABE500	Ramp Type: PerpDiag	Initial Pass/Fail: Fail	Overall Compliance: No
Severity Score: 12.5			
Codes/Mitigation Info/Possible Solution		Field Measurements/Component Compliance

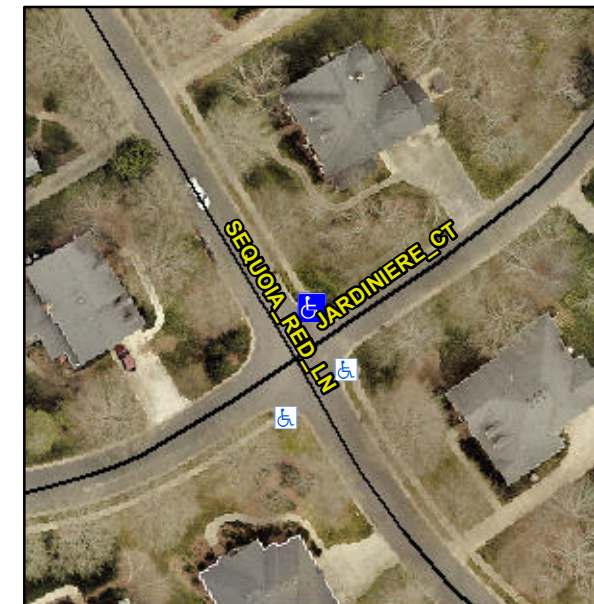
Not Found, R304.5.3

Compliance	Description	Data	Compliance	Description	Data
N/A	Ramp Length (in)	30.5	Yes	Ramp Slope (%)	6.1
Yes	Ramp Width (in)	48.0	No	Ramp XSlope (%)	5.4
N/A	Flare Type LT	N/A	N/A	Flare Type RT	N/A
N/A	Flare Slope LT (%)	N/A	N/A	Flare Slope RT (%)	N/A
N/A	Flare Traversable LT?	N/A	N/A	Flare Traversable RT?	N/A
N/A	Landing Length (in)	N/A	N/A	DWS Provided?	N/A
N/A	Landing Width (in)	N/A	N/A	DWS Contrast?	N/A
N/A	Landing Slope (%)	N/A	N/A	DWS Length (in)	N/A
N/A	Landing X Slope (%)	N/A	N/A	DWS Full Width?	N/A
N/A	Landing Curb? (Y/N)	N/A	N/A	DWS Offset (in)	N/A
N/A	Shared Landing?	N/A			
N/A	Gutter Ponding?	N/A	N/A	Gutter Slope (%)	N/A
N/A	Gutter Lip Ht (in)	1.0	N/A	Gutter X Slope (%)	N/A
N/A	Painted X Walk1?	No	N/A	Painted X Walk2?	No
	X Walk 1 Direction	To SW		X Walk 2 Direction	To S
N/A	X Walk 1 Width (in)	N/A	N/A	X Walk 2 Width (in)	N/A
	X Walk 1 Slope (%)	1.9		X Walk 2 Slope (%)	5.8
	X Walk 1 X Slope (%)	4.8		X Walk 2 X Slope (%)	1.1

N/A	Ramp inside XWalk1?	N/A	N/A	Ramp inside XWalk2?	N/A
	Road Slope (%)	3.3	N/A	Clear Space?	N/A
	Road X Slope (%)	2.0	N/A	Clear Space to XWalk (in)	N/A
N/A	Any Obstructions?	N/A	N/A	Storm Grate/Utility Hazard?	N/A
	Obstruction Type			Storm Grate/Utility Type	
		N/A			N/A
		Yes		Surface Condition? (G/P)	Good

Remove & Replace Curb Ramp With Two New Directional Ramps or Equivalent.
