Access Compliance Report

Public Rights-of-Way

(Curb Ramps)

Intersection ID: 10205	Main Street: STATESVILLE_AV	Cross Street: OAKLAWN_AV	Location: SW
ADA ID: 7E1BF8D2E520	Ramp Type: Perp	Initial Pass/Fail: Pass	Overall Compliance: No
		Severity Score: 0.25

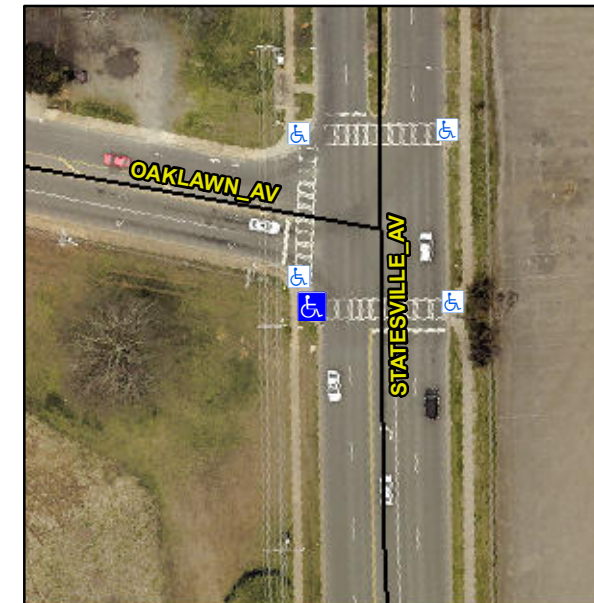
Not Found, R304.5.3, R304.2.2-Perp, R304.3.2-Para

Compliance	Description	Data	Compliance	Description	Data
N/A	Ramp Length (in)	103.0	Yes	Ramp Slope (%)	5.8
Yes	Ramp Width (in)	48.0	No	Ramp XSlope (%)	2.6
N/A	Flare Type LT	Sloped	N/A	Flare Type RT	N/A
N/A	Flare Slope LT (%)	3.8	N/A	Flare Slope RT (%)	5.7
N/A	Flare Traversable LT?	No	N/A	Flare Traversable RT?	No
Yes	Landing Length (in)	60.0	Yes	DWS Provided?	Yes
Yes	Landing Width (in)	73.0	Yes	DWS Contrast?	Yes
No	Landing Slope (%)	3.8	Yes	DWS Length (in)	25.0
Yes	Landing X Slope (%)	1.0	Yes	DWS Full Width?	Yes
N/A	Landing Curb? (Y/N)	No	Yes	DWS Offset (in)	0.0
N/A	Shared Landing?	No			
Yes	Gutter Ponding?	No	Yes	Gutter Slope (%)	3.7
Yes	Gutter Lip Ht (in)	0.0	Yes	Gutter X Slope (%)	0.8
N/A	Painted X Walk1?	Yes	N/A	Painted X Walk2?	N/A
	X Walk 1 Direction	To E		X Walk 2 Direction	N/A
N/A	X Walk 1 Width (in)	110.5	N/A	X Walk 2 Width (in)	N/A
	X Walk 1 Slope (%)	1.8		X Walk 2 Slope (%)	N/A
	X Walk 1 X Slope (%)	1.0		X Walk 2 X Slope (%)	N/A

Yes	Ramp inside XWalk1?	Yes	N/A	Ramp inside XWalk2?	N/A
	Road Slope (%)	N/A	N/A	Clear Space?	Yes
	Road X Slope (%)	N/A	N/A	Clear Space to XWalk (in)	N/A
Yes	Any Obstructions?	No	Yes	Storm Grate/Utility Hazard?	No
	Obstruction Type			Storm Grate/Utility Type	
			N/A		N/A
			Yes	Surface Condition? (G/P)	Good

Remove & Replace Entire Ramp.

Total Cost: \$ 1850.00
