Access Compliance Report

Public Rights-of-Way (Curb Ramps)

Intersection ID: 17670	Main Street: RIDGEWOOD_AV	Cross Street: SELWYN_AV	Location: W
ADA ID: 7E209E8304AF	Ramp Type: Directional1	Initial Pass/Fail: Fail	Overall Compliance: No
			Severity Score: 21.25

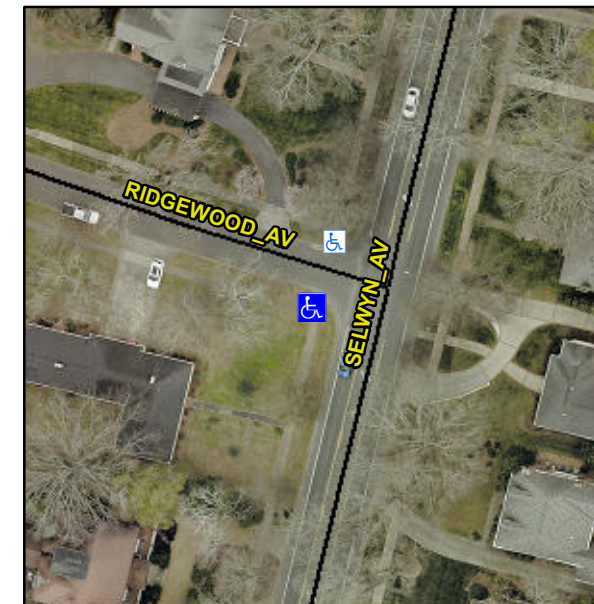
R304.5.1, R304.2.2

Compliance	Description	Data	Compliance	Description	Data
N/A	Ramp Length (in)	93.0	N/A	Grade Break?	N/A
No	Ramp Width (in)	45.0	N/A	Grade Break Slope (%)	0.0
No	Ramp Slope (%)	10.8	N/A	Grade Break XSlope (%)	0.0
Yes	Ramp XSlope (%)	1.6			
N/A	Flare Type LT	N/A	N/A	Flare Type RT	N/A
N/A	Flare Slope LT (%)	N/A	N/A	Flare Slope RT (%)	0.0
N/A	Flare Traversable LT?	N/A	N/A	Flare Traversable RT?	N/A
N/A	Landing Length (in)	0.0	N/A	DWS Provided?	N/A
N/A	Landing Width (in)	0.0	N/A	DWS Contrast?	N/A
N/A	Landing Slope (%)	0.0	N/A	DWS Length (in)	N/A
N/A	Landing X Slope (%)	0.0	N/A	DWS Full Width?	N/A
N/A	Landing Curb? (Y/N)	N/A	N/A	DWS Offset LT (in)	N/A
N/A	Shared Landing?	N/A	N/A	DWS Offset RT (in)	N/A
N/A	Gutter Ponding?	0.0	N/A	Gutter Slope (%)	N/A
N/A	Gutter Lip Ht (in)	0.0	N/A	Gutter X Slope (%)	N/A
N/A	Painted X Walk1?	No		Road Slope (%)	3.8
	X Walk 1 Direction	To N		Road X Slope (%)	1.9
	X Walk 1 Width (in)	N/A		Clear Space?	N/A

X Walk 1 Slope (%)	3.8	N/A	Clear Space to XWalk (in)	N/A
	X Walk 1 X Slope (%)	1.9	N/A	Storm Grate/Utility Hazard?	N/A
N/A	Ramp inside XWalk1?	N/A		Storm Grate/Utility Type	
N/A	Any Obstructions?	N/A			N/A
	Obstruction Type		Yes	Surface Condition? (G/P)	Good
			N/A	Curb Slope (%)	0.4

Remove & Replace Entire Ramp.
