# Access Compliance Report

## Public Rights-of-Way

| Intersection ID: 20172 | Main Street: CORTELYOU_RD | Cross Street: FOXCROFT_RD | Location: SE |
| ADA ID: 7E2A3C94CDEF | Ramp Type: BlendTrans1 | Initial Pass/Fail: Fail | Overall Compliance: No |

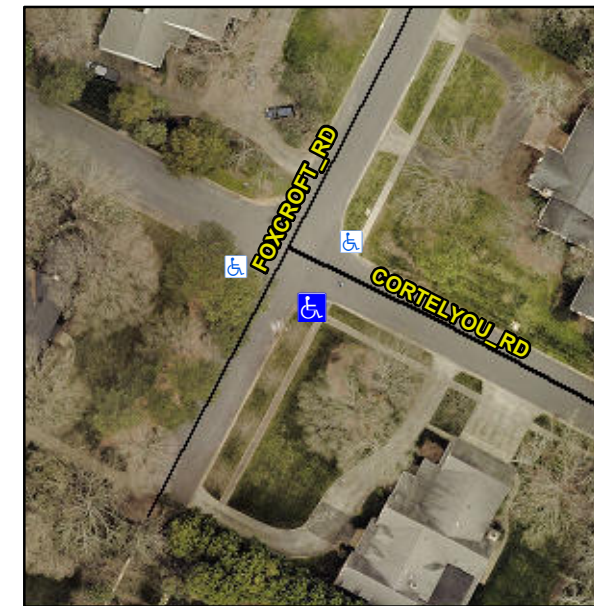
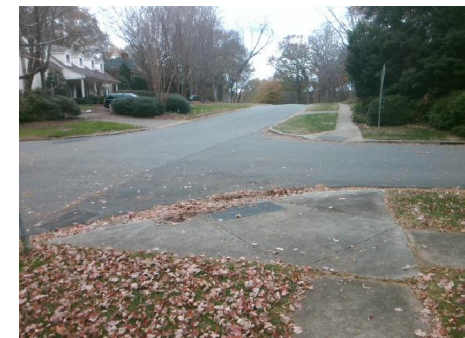
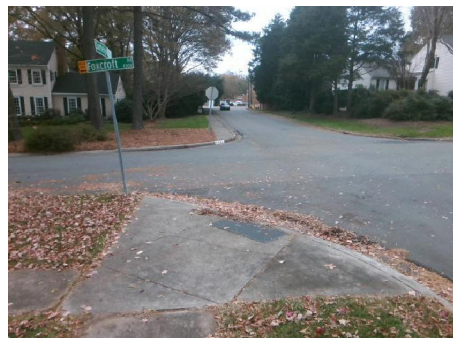
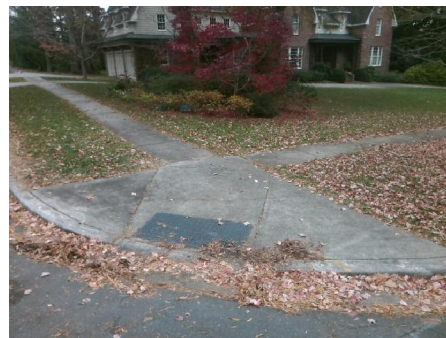
| | | Severity Score: 12.5 | |

**Not Found, R304.5.3**

| Compliance | Description | Data | Compliance | Description | Data |
|---|---|---|---|---|---|
| Yes | Ramp Width (in) | 48.0 | No | BlendTrans XSlope (%) | 5.3 |
| | | | No | Curb Slope (%) | 16.7 |

**Remove & Replace Curb Ramp With Two New Directional Ramps or Equivalent.**
