# Access Compliance Report

## Public Rights-of-Way

### (Curb Ramps)

Intersection ID: 2683	Main Street: FAIRVISTA_DR	Cross Street: REGAL_CT	Location: SE
ADA ID: 7E2B54915C3A	Ramp Type: BlendTrans2	Initial Pass/Fail: Pass	Overall Compliance: No
		Severity Score: 17.5

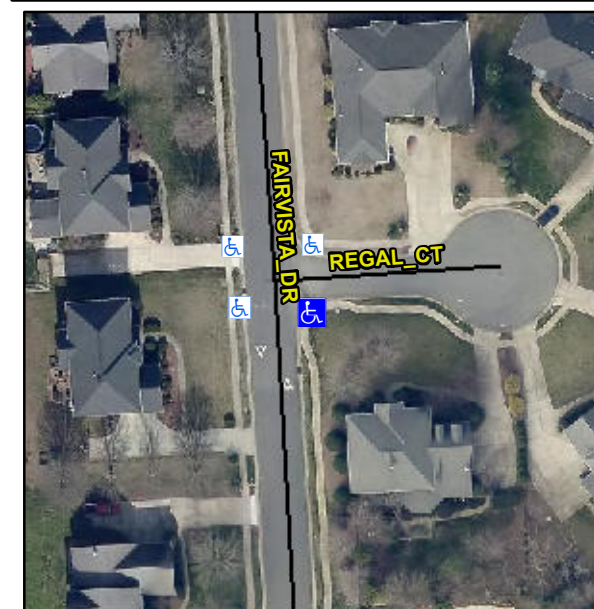
**Not Found, R304.2.3, R305, R302.7.2**

Compliance	Description	Data	Compliance	Description	Data
N/A	Ramp Length (in)	46.0	Yes	BlendTrans Slope (%)	2.9
Yes	Ramp Width (in)	231.0	Yes	BlendTrans XSlope (%)	1.0
N/A	Flare Type LT	Sloped	N/A	Flare Type RT	Sloped
No	Flare Slope LT (%)	N/A	No	Flare Slope RT (%)	N/A
N/A	Flare Traversable LT?	Yes	N/A	Flare Traversable RT?	Yes
N/A	Landing Length (in)	N/A	No	DWS Provided?	No
N/A	Landing Width (in)	N/A	N/A	DWS Contrast?	No
N/A	Landing Slope (%)	N/A	N/A	DWS Length (in)	N/A
N/A	Landing X Slope (%)	N/A	N/A	DWS Full Width?	No
N/A	Landing Curb? (Y/N)	No	N/A	DWS Offset (in)	N/A
N/A	Shared Landing?	No			
Yes	Gutter Ponding?	No	Yes	Gutter Slope (%)	4.1
No	Gutter Lip Ht (in)	0.5	Yes	Gutter X Slope (%)	1.6
N/A	Painted X Walk1?	No	N/A	Painted X Walk2?	No
	X Walk 1 Direction	To N		X Walk 2 Direction	To W
	X Walk 1 Width (in)	N/A		X Walk 2 Width (in)	N/A
	X Walk 1 Slope (%)	1.6		X Walk 2 Slope (%)	N/A
	X Walk 1 X Slope (%)	1.8		X Walk 2 X Slope (%)	N/A

N/A	Ramp inside XWalk1?	N/A	N/A	Ramp inside XWalk2?	N/A
	Road Slope (%)	1.8		Clear Space?	Yes
	Road X Slope (%)	1.6	N/A	Clear Space to XWalk (in)	N/A
Yes	Any Obstructions?	No	Yes	Storm Grate/Utility Hazard?	No
	Obstruction Type			Storm Grate/Utility Type	
		N/A			N/A
			Yes	Surface Condition? (G/P)	Good
			No	Curb Slope (%)	10.1

**Remove & Replace Curb Ramp With Two New Directional Ramps or Equivalent.**

Total Cost: \$ 3200.00
