Access Compliance Report

Public Rights-of-Way

(Curb Ramps)

Intersection ID: 5526	Main Street: COLLINS-AIKMAN_DR	Cross Street: UNIVERSITY_CENTER_BV	Location: W
ADA ID: 7E2CF3B8C3E4	Ramp Type: Perp	Initial Pass/Fail: Fail	Overall Compliance: No
Severity Score: 21.25			
Codes/Mitigation Info/Possible Solution		Field Measurements/Component Compliance

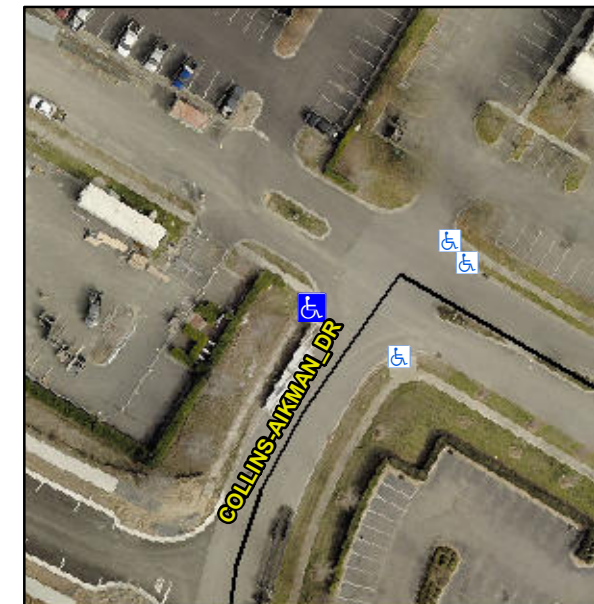
Not Found, R304.5.1, R304.2.2

Compliance	Description	Data	Compliance	Description	Data
N/A	Ramp Length (in)	68.0	No	Ramp Slope (%)	9.8
No	Ramp Width (in)	47.0	Yes	Ramp XSlope (%)	1.9
N/A	Flare Type LT	N/A	N/A	Flare Type RT	N/A
N/A	Flare Slope LT (%)	N/A	N/A	Flare Slope RT (%)	N/A
N/A	Flare Traversable LT?	N/A	N/A	Flare Traversable RT?	N/A
N/A	Landing Length (in)	N/A	N/A	DWS Provided?	N/A
N/A	Landing Width (in)	N/A	N/A	DWS Contrast?	N/A
N/A	Landing Slope (%)	N/A	N/A	DWS Length (in)	N/A
N/A	Landing X Slope (%)	N/A	N/A	DWS Full Width?	N/A
N/A	Landing Curb? (Y/N)	N/A	N/A	DWS Offset (in)	N/A
N/A	Shared Landing?	N/A			
N/A	Gutter Ponding?	N/A	N/A	Gutter Slope (%)	N/A
N/A	Gutter Lip Ht (in)	1.5	N/A	Gutter X Slope (%)	N/A
N/A	Painted X Walk1?	No	N/A	Painted X Walk2?	N/A
	X Walk 1 Direction	To SE		X Walk 2 Direction	N/A
N/A	X Walk 1 Width (in)	N/A	N/A	X Walk 2 Width (in)	N/A
	X Walk 1 Slope (%)	0.0		X Walk 2 Slope (%)	N/A
	X Walk 1 X Slope (%)	0.2		X Walk 2 X Slope (%)	N/A

Remove & Replace Entire Ramp.

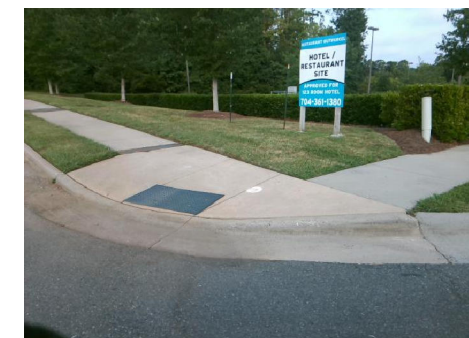
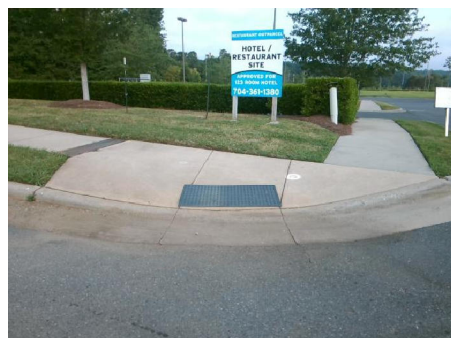
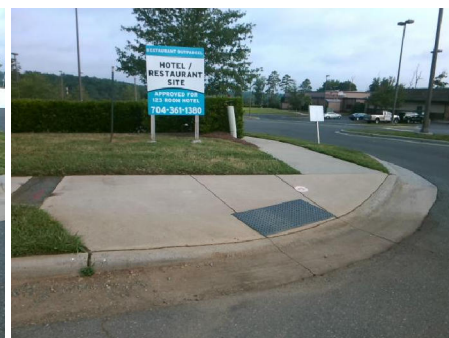
N/A	Ramp inside XWalk1?	N/A	N/A	Ramp inside XWalk2?	N/A
	Road Slope (%)	N/A	N/A	Clear Space?	N/A
	Road X Slope (%)	N/A	N/A	Clear Space to XWalk (in)	N/A
N/A	Any Obstructions?	N/A	N/A	Storm Grate/Utility Hazard?	N/A
	Obstruction Type			Storm Grate/Utility Type	
		N/A			N/A
			Yes	Surface Condition? (G/P)	Good
