# Access Compliance Report

## Public Rights-of-Way

### (Curb Ramps)

| Intersection ID: 14621 | Main Street: KENMORE_AV | Cross Street: N_LAUREL_AV | Location: S |

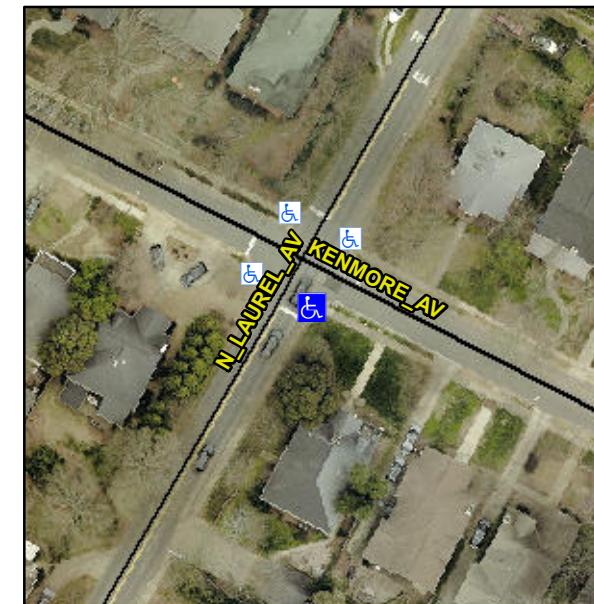
| ADA ID: 7E362590CDC8 | Ramp Type: PerpDiag | Initial Pass/Fail: Fail | Overall Compliance: No |
| | | Severity Score: 12.5 | |

**Not Found, R304.2.2**

| Compliance | Description | Data | Compliance | Description | Data |
|---|---|---|---|---|---|
| N/A | Ramp Length (in) | 45.0 | No | Ramp Slope (%) | 8.4 |

**Remove & Replace Curb Ramp With Two New Directional Ramps or Equivalent.**

Total Cost: \$ 3200.00
