# Access Compliance Report

## Public Rights-of-Way

### (Curb Ramps)

Intersection ID: 10038417	Main Street: SOUTH_REA_PARK_LN	Cross Street: N/A	Location: S
ADA ID: 7E444EB79538	Ramp Type: Perp	Initial Pass/Fail: Fail	Overall Compliance: No
Severity Score: 12.5			
Codes/Mitigation Info/Possible Solution		Field Measurements/Component Compliance

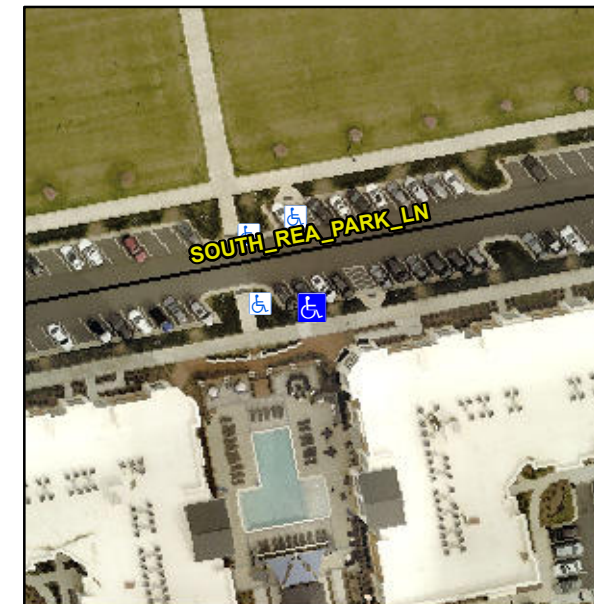
**Not Found, R304.2.2**

Compliance	Description	Data	Compliance	Description	Data
N/A	Ramp Length (in)	95.0	No	Ramp Slope (%)	8.5
Yes	Ramp Width (in)	59.0	Yes	Ramp XSlope (%)	0.5
N/A	Flare Type LT	N/A	N/A	Flare Type RT	N/A
N/A	Flare Slope LT (%)	N/A	N/A	Flare Slope RT (%)	N/A
N/A	Flare Traversable LT?	N/A	N/A	Flare Traversable RT?	N/A
N/A	Landing Length (in)	N/A	N/A	DWS Provided?	N/A
N/A	Landing Width (in)	N/A	N/A	DWS Contrast?	N/A
N/A	Landing Slope (%)	N/A	N/A	DWS Length (in)	N/A
N/A	Landing X Slope (%)	N/A	N/A	DWS Full Width?	N/A
N/A	Landing Curb? (Y/N)	N/A	N/A	DWS Offset (in)	N/A
N/A	Shared Landing?	N/A			
N/A	Gutter Ponding?	N/A	N/A	Gutter Slope (%)	N/A
N/A	Gutter Lip Ht (in)	N/A	N/A	Gutter X Slope (%)	N/A
N/A	Painted X Walk1?	No	N/A	Painted X Walk2?	N/A
	X Walk 1 Direction	To N		X Walk 2 Direction	N/A
N/A	X Walk 1 Width (in)	N/A	N/A	X Walk 2 Width (in)	N/A
	X Walk 1 Slope (%)	2.9		X Walk 2 Slope (%)	N/A
	X Walk 1 X Slope (%)	2.3		X Walk 2 X Slope (%)	N/A

**Remove & Replace Entire Ramp.**

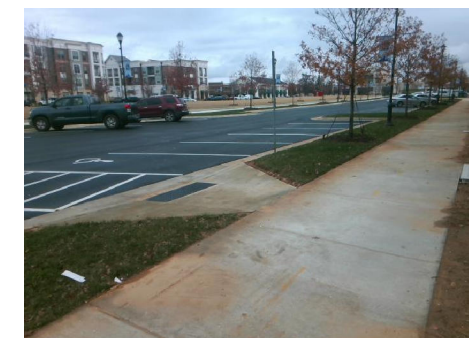
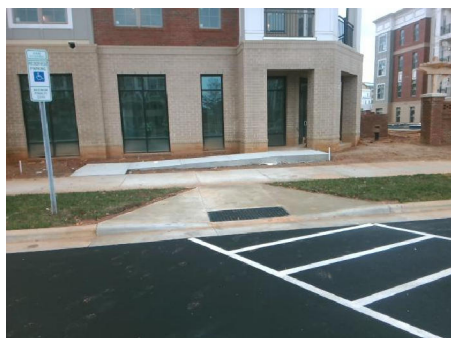
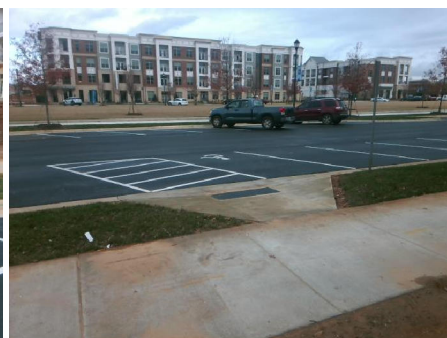
N/A	Ramp inside XWalk1?	N/A	N/A	Ramp inside XWalk2?	N/A
	Road Slope (%)	N/A	N/A	Clear Space?	N/A
	Road X Slope (%)	N/A	N/A	Clear Space to XWalk (in)	N/A
N/A	Any Obstructions?	N/A	N/A	Storm Grate/Utility Hazard?	N/A
	Obstruction Type			Storm Grate/Utility Type	
		N/A			N/A
			Yes	Surface Condition? (G/P)	Good
