Access Compliance Report Public Rights-of-Way (Curb Ramps)

Intersection ID: 29677Main Street:CAMERON_CREEK_DRCross Street:HUNTINGTON_RIDGE_CTLocation:NWADA ID: 7E4A8E595107Ramp Type:PerpDiagInitial Pass/Fail:FailOverall Compliance:NoSeverity Score:8.75

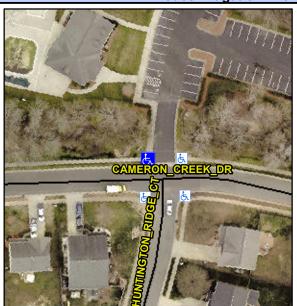
Not Found, R304.5.1

Comp	liance Description	Data	Component Compliance a Compliance Description		
N/A	Ramp Length (in)	36.0	Yes	Ramp Slope (%)	<u>Data</u> 7.4
No No	Ramp Width (in)	47.5	Yes	Ramp XSlope (%)	1.0
N/A	. ,	47.5 N/A	N/A	,	N/A
	Flare Type LT			Flare Type RT	
N/A	Flare Slope LT (%)	N/A	N/A	Flare Slope RT (%)	N/A
N/A	Flare Traversable LT?	N/A	N/A	Flare Traversable RT?	N/A
N/A	Landing Length (in)	N/A	N/A	DWS Provided?	N/A
N/A	Landing Width (in)	N/A	N/A	DWS Contrast?	N/A
N/A	Landing Slope (%)	N/A	N/A	DWS Length (in)	N/A
N/A	Landing X Slope (%)	N/A	N/A	DWS Full Width?	N/A
N/A	Landing Curb? (Y/N)	N/A	N/A	DWS Offset (in)	N/A
N/A	Shared Landing?	N/A			
N/A	Gutter Ponding?	N/A	N/A	Gutter Slope (%)	N/A
N/A	Gutter Lip Ht (in)	N/A	N/A	Gutter X Slope (%)	N/A
N/A	Painted X Walk1?	No	N/A	Painted X Walk2?	No
	X Walk 1 Direction	To S		X Walk 2 Direction	То Е
N/A	X Walk 1 Width (in)	N/A	N/A	X Walk 2 Width (in)	N/A
	X Walk 1 Slope (%)	2.2		X Walk 2 Slope (%)	1.5

X Walk 1 X Slope (%)	1.3		X Walk 2 X Slope (%)	6.7
N/A	Ramp inside XWalk1?	N/A	N/A	Ramp inside XWalk2?	N/A
	Road Slope (%)	2.5	N/A	Clear Space?	N/A
	Road X Slope (%)	0.4	N/A	Clear Space to XWalk (in)	N/A
N/A	Any Obstructions?	N/A	N/A	Storm Grate/Utility Hazard?	N/A
	Obstruction Type			Storm Grate/Utility Type	
	,,	N/A		, ,,	N/A
			Yes	Surface Condition? (G/P)	Good
	The same of the sa	'	,	(27.)

Remove & Replace Curb Ramp With
Two New Directional Ramps or
Equivalent.
