Access Compliance Report Public Rights-of-Way (Curb Ramps)

Intersection ID: 22498 Main Street: WESTINGHOUSE_BV Cross Street: BROOKFORD_ST Location: NE

ADA ID: 7E51FCF137FD Ramp Type: PerpDiag Initial Pass/Fail: Pass Overall Compliance: No Severity Score: 12.75

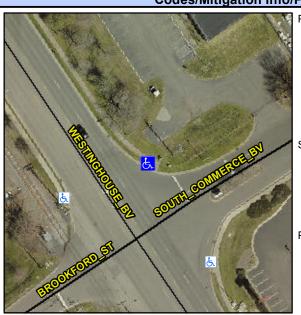
Field Measurements/Component Compnance					
Compliance Description		Data	Compliance Description		Data
N/A	Ramp Length (in)	115.0	Yes	Ramp Slope (%)	6.4
Yes	Ramp Width (in)	48.0	No	Ramp XSlope (%)	4.6
N/A	Flare Type LT	Sloped	N/A	Flare Type RT	N/A
N/A	Flare Slope LT (%)	9.3	N/A	Flare Slope RT (%)	2.9
N/A	Flare Traversable LT?	No	N/A	Flare Traversable RT?	No
No	Landing Length (in)	N/A	Yes	DWS Provided?	Yes
No	Landing Width (in)	N/A	Yes	DWS Contrast?	Yes
No	Landing Slope (%)	N/A	Yes	DWS Length (in)	24.0
No	Landing X Slope (%)	N/A	No	DWS Full Width?	No
N/A	Landing Curb? (Y/N)	No	No	DWS Offset (in)	10.0
N/A	Shared Landing?	No			
Yes	Gutter Ponding?	No	Yes	Gutter Slope (%)	2.7
Yes	Gutter Lip Ht (in)	0.0	No	Gutter X Slope (%)	5.0
N/A	Painted X Walk1?	No	N/A	Painted X Walk2?	No
	X Walk 1 Direction	To W		X Walk 2 Direction	To S
N/A	X Walk 1 Width (in)	N/A	N/A	X Walk 2 Width (in)	N/A
	X Walk 1 Slope (%)	8.9		X Walk 2 Slope (%)	0.5

X Walk 1 X Slope (%)	0.2		X Walk 2 X Slope (%)	8.2
N/A	Ramp inside XWalk1?	N/A	N/A	Ramp inside XWalk2?	N/A
	Road Slope (%)	5.4	N/A	Clear Space?	Yes
	Road X Slope (%)	8.5	N/A	Clear Space to XWalk (in)	N/A
Yes	Any Obstructions?	No	Yes	Storm Grate/Utility Hazard?	No
	Obstruction Type		l	Storm Grate/Utility Type	
		N/A			N/A
			Yes	Surface Condition? (G/P)	Good

Remove & Replace Curb Ramp With Two New Directional Ramps or Equivalent. Remove & Replace Gutter.

R304.5.3, R304.2.1, R304.2.2-Perp, R304.3.2-Para, R305.1.4, R305.2
