# Access Compliance Report

## Public Rights-of-Way

### (Curb Ramps)

Intersection ID: 2772	Main Street: BELL'S_MILL_DR	Cross Street: TARLAND_LN	Location: SW
ADA ID: 7E56E66C2EA1	Ramp Type: PerpDiag	Initial Pass/Fail: Fail	Overall Compliance: No
Severity Score: 21.25			
Codes/Mitigation Info/Possible Solution		Field Measurements/Component Compliance

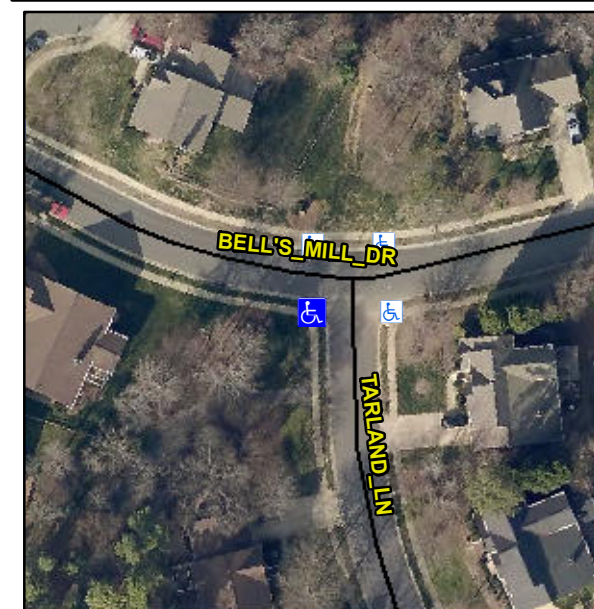
Compliance	Description	Data	Compliance	Description	Data
N/A	Ramp Length (in)	48.0	Yes	Ramp Slope (%)	7.6
No	Ramp Width (in)	36.0	No	Ramp XSlope (%)	6.8
N/A	Flare Type LT	N/A	N/A	Flare Type RT	N/A
N/A	Flare Slope LT (%)	N/A	N/A	Flare Slope RT (%)	N/A
N/A	Flare Traversable LT?	N/A	N/A	Flare Traversable RT?	N/A
N/A	Landing Length (in)	N/A	N/A	DWS Provided?	N/A
N/A	Landing Width (in)	N/A	N/A	DWS Contrast?	N/A
N/A	Landing Slope (%)	N/A	N/A	DWS Length (in)	N/A
N/A	Landing X Slope (%)	N/A	N/A	DWS Full Width?	N/A
N/A	Landing Curb? (Y/N)	N/A	N/A	DWS Offset (in)	N/A
N/A	Shared Landing?	N/A			
N/A	Gutter Ponding?	N/A	N/A	Gutter Slope (%)	N/A
N/A	Gutter Lip Ht (in)	N/A	N/A	Gutter X Slope (%)	N/A
N/A	Painted X Walk1?	No	N/A	Painted X Walk2?	No
	X Walk 1 Direction	To E		X Walk 2 Direction	To N
N/A	X Walk 1 Width (in)	N/A	N/A	X Walk 2 Width (in)	N/A
	X Walk 1 Slope (%)	4.2		X Walk 2 Slope (%)	1.2
	X Walk 1 X Slope (%)	2.8		X Walk 2 X Slope (%)	2.2

N/A	Ramp inside XWalk1?	N/A	N/A	Ramp inside XWalk2?	N/A
	Road Slope (%)	2.8	N/A	Clear Space?	N/A
	Road X Slope (%)	5.6	N/A	Clear Space to XWalk (in)	N/A
N/A	Any Obstructions?	N/A	N/A	Storm Grate/Utility Hazard?	N/A
	Obstruction Type			Storm Grate/Utility Type	
		N/A			N/A
			Yes	Surface Condition? (G/P)	Good

Possible Solutions:

**Remove & Replace Curb Ramp With Two New Directional Ramps or Equivalent.**

**R304.5.1, R304.5.3**
