Access Compliance Report

Public Rights-of-Way

(Curb Ramps)

Intersection ID: 18017	Main Street: CHELSEA_DR	Cross Street: DELLWOOD_AV	Location: NE
ADA ID: 7E57A35C5947	Ramp Type: Perp	Initial Pass/Fail: Fail	Overall Compliance: No
Codes/Mitigation Info/Possible Solution			Severity Score: 35
			Field Measurements/Component Compliance

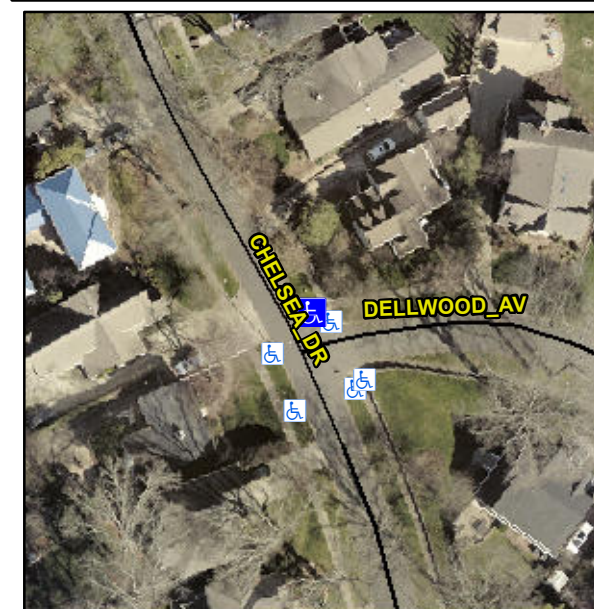
Not Found, R304.5.1, R304.2.2

Compliance	Description	Data	Compliance	Description	Data
N/A	Ramp Length (in)	105.0	No	Ramp Slope (%)	18.5
No	Ramp Width (in)	44.0	Yes	Ramp XSlope (%)	3.3
N/A	Flare Type LT	N/A	N/A	Flare Type RT	N/A
N/A	Flare Slope LT (%)	N/A	N/A	Flare Slope RT (%)	N/A
N/A	Flare Traversable LT?	N/A	N/A	Flare Traversable RT?	N/A
N/A	Landing Length (in)	N/A	N/A	DWS Provided?	N/A
N/A	Landing Width (in)	N/A	N/A	DWS Contrast?	N/A
N/A	Landing Slope (%)	N/A	N/A	DWS Length (in)	N/A
N/A	Landing X Slope (%)	N/A	N/A	DWS Full Width?	N/A
N/A	Landing Curb? (Y/N)	N/A	N/A	DWS Offset (in)	N/A
N/A	Shared Landing?	N/A			
N/A	Gutter Ponding?	N/A	N/A	Gutter Slope (%)	N/A
N/A	Gutter Lip Ht (in)	N/A	N/A	Gutter X Slope (%)	N/A
N/A	Painted X Walk1?	No	N/A	Painted X Walk2?	N/A
	X Walk 1 Direction	To W		X Walk 2 Direction	N/A
N/A	X Walk 1 Width (in)	N/A	N/A	X Walk 2 Width (in)	N/A
	X Walk 1 Slope (%)	2.1		X Walk 2 Slope (%)	N/A
	X Walk 1 X Slope (%)	10.3		X Walk 2 X Slope (%)	N/A

Remove & Replace Entire Ramp.

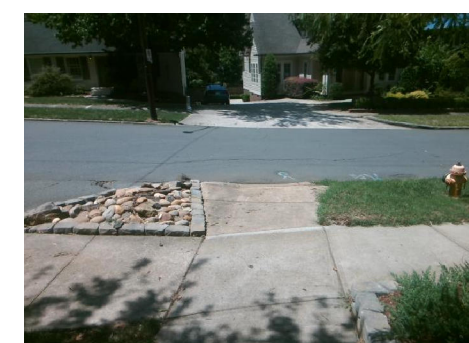
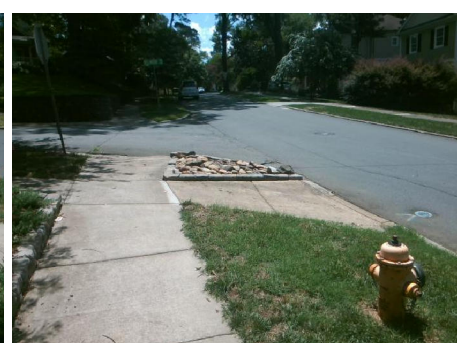
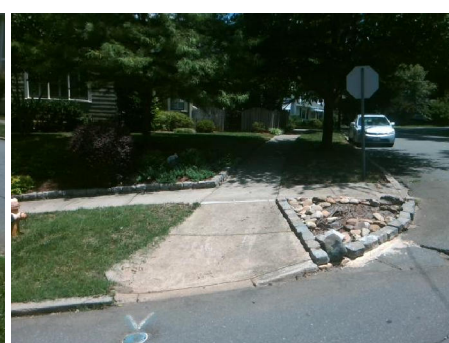
N/A	Ramp inside XWalk1?	N/A	N/A	Ramp inside XWalk2?	N/A
	Road Slope (%)	N/A	N/A	Clear Space?	N/A
	Road X Slope (%)	N/A	N/A	Clear Space to XWalk (in)	N/A
N/A	Any Obstructions?	N/A	N/A	Storm Grate/Utility Hazard?	N/A
	Obstruction Type			Storm Grate/Utility Type	
		N/A			N/A
			Yes	Surface Condition? (G/P)	Good
