# Access Compliance Report

## Public Rights-of-Way

### (Curb Ramps)

Intersection ID: 20439	Main Street: FAIRVIEW_RD	Cross Street: SHARON_RD	Location: NE
ADA ID: 7E639993F12A	Ramp Type: Perp	Initial Pass/Fail: Fail	Overall Compliance: No
		Severity Score: 8.75

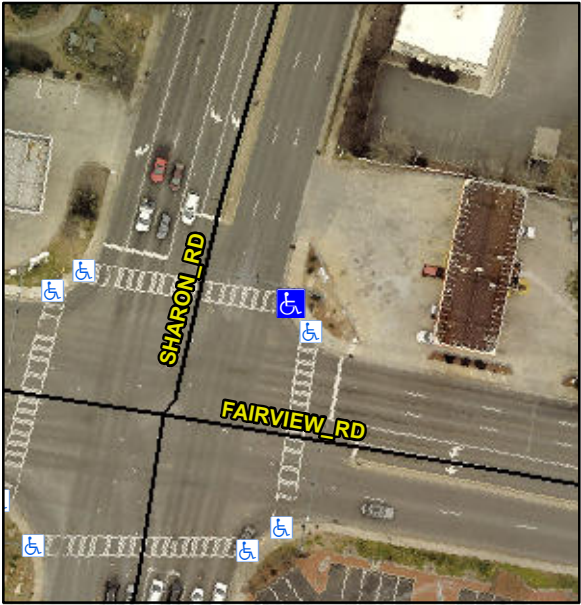
Possible Solutions:		<b>Compliance</b>	<b>Description</b>	<b>Data</b>
	<b>Remove &amp; Replace Entire Ramp.</b>		<b>Yes</b>	Ramp Length (in)	84.0
			<b>No</b>	Ramp Width (in)	37.0
			<b>N/A</b>	Flare Type LT	N/A
			<b>N/A</b>	Flare Slope LT (%)	N/A
			<b>N/A</b>	Flare Traversable LT?	N/A
			<b>N/A</b>	Landing Length (in)	N/A
			<b>N/A</b>	Landing Width (in)	N/A
			<b>N/A</b>	Landing Slope (%)	N/A
			<b>N/A</b>	Landing X Slope (%)	N/A
<p>Surveyor Notes:</p> <p><b>N/A</b></p>			<b>N/A</b>	Landing Curb? (Y/N)	N/A
			<b>N/A</b>	Shared Landing?	N/A
			<b>N/A</b>	Gutter Ponding?	N/A
			<b>N/A</b>	Gutter Lip Ht (in)	N/A
			<b>N/A</b>	Painted X Walk1?	Yes
				X Walk 1 Direction	To NW
			<b>N/A</b>	X Walk 1 Width (in)	111.0
				X Walk 1 Slope (%)	2.6
				X Walk 1 X Slope (%)	0.4
			<b>N/A</b>	Ramp inside XWalk1?	Yes
<p>PROW/ADA:</p> <p><b>Not Found, R304.5.1</b></p>			<b>N/A</b>	Road Slope (%)	N/A
