# Access Compliance Report

## Public Rights-of-Way

### (Curb Ramps)

Intersection ID: 50470	Main Street: EVERTON_DR	Cross Street: LENOX_POINTE_DR	Location: SW
ADA ID: 7E6B5A182FAC	Ramp Type: Perp	Initial Pass/Fail: Fail	Overall Compliance: No
		Severity Score: 12.5

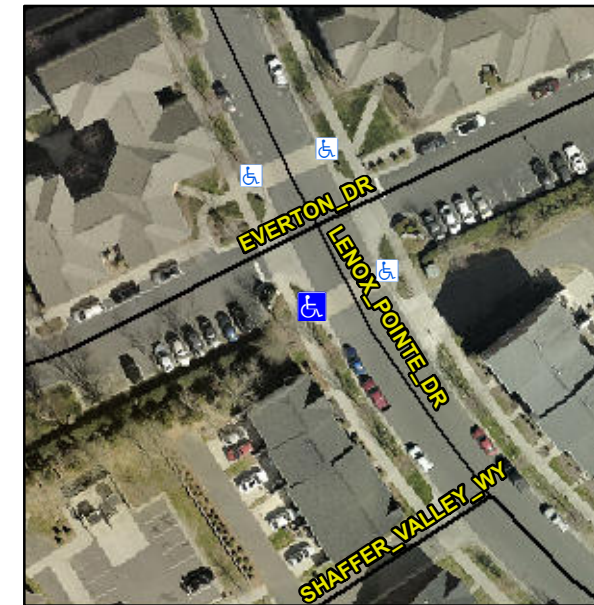
**Not Found, R304.2.2**

Compliance	Description	Data	Compliance	Description	Data
N/A	Ramp Length (in)	85.0	No	Ramp Slope (%)	9.3
Yes	Ramp Width (in)	48.0	Yes	Ramp XSlope (%)	0.4
N/A	Flare Type LT	N/A	N/A	Flare Type RT	N/A
N/A	Flare Slope LT (%)	N/A	N/A	Flare Slope RT (%)	N/A
N/A	Flare Traversable LT?	N/A	N/A	Flare Traversable RT?	N/A
N/A	Landing Length (in)	N/A	N/A	DWS Provided?	N/A
N/A	Landing Width (in)	N/A	N/A	DWS Contrast?	N/A
N/A	Landing Slope (%)	N/A	N/A	DWS Length (in)	N/A
N/A	Landing X Slope (%)	N/A	N/A	DWS Full Width?	N/A
N/A	Landing Curb? (Y/N)	N/A	N/A	DWS Offset (in)	N/A
N/A	Shared Landing?	N/A			
N/A	Gutter Ponding?	N/A	N/A	Gutter Slope (%)	N/A
N/A	Gutter Lip Ht (in)	N/A	N/A	Gutter X Slope (%)	N/A
N/A	Painted X Walk1?	Yes	N/A	Painted X Walk2?	N/A
	X Walk 1 Direction	To E		X Walk 2 Direction	N/A
N/A	X Walk 1 Width (in)	144.0	N/A	X Walk 2 Width (in)	N/A
	X Walk 1 Slope (%)	0.5		X Walk 2 Slope (%)	N/A
	X Walk 1 X Slope (%)	2.4		X Walk 2 X Slope (%)	N/A

N/A	Ramp inside XWalk1?	Yes	N/A	Ramp inside XWalk2?	N/A
	Road Slope (%)	N/A	N/A	Clear Space?	N/A
	Road X Slope (%)	N/A	N/A	Clear Space to XWalk (in)	N/A
N/A	Any Obstructions?	N/A	N/A	Storm Grate/Utility Hazard?	N/A
	Obstruction Type			Storm Grate/Utility Type	
		N/A			N/A
			Yes	Surface Condition? (G/P)	Good

**Remove & Replace Entire Ramp.**
