Access Compliance Report

Public Rights-of-Way

(Curb Ramps)

Intersection ID: 10023686	Main Street: COCA-COLA PLAZA	Cross Street: N/A	Location: SE
ADA ID: 7E6C7FB00798	Ramp Type: Perp	Initial Pass/Fail: Fail	Overall Compliance: No
Severity Score: 26.25			
Codes/Mitigation Info/Possible Solution		Field Measurements/Component Compliance

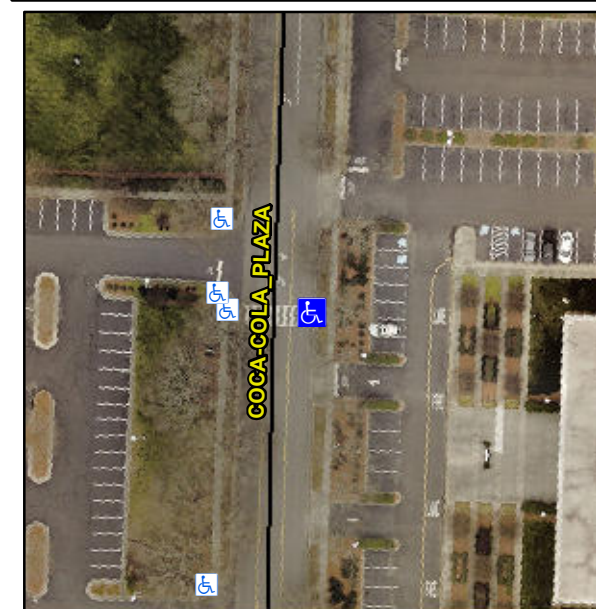
R304.2.2, R304.5.3

Compliance	Description	Data	Compliance	Description	Data
N/A	Ramp Length (in)	77.0	No	Ramp Slope (%)	12.6
Yes	Ramp Width (in)	48.0	No	Ramp XSlope (%)	2.1
N/A	Flare Type LT	N/A	N/A	Flare Type RT	N/A
N/A	Flare Slope LT (%)	N/A	N/A	Flare Slope RT (%)	N/A
N/A	Flare Traversable LT?	N/A	N/A	Flare Traversable RT?	N/A
N/A	Landing Length (in)	N/A	N/A	DWS Provided?	N/A
N/A	Landing Width (in)	N/A	N/A	DWS Contrast?	N/A
N/A	Landing Slope (%)	N/A	N/A	DWS Length (in)	N/A
N/A	Landing X Slope (%)	N/A	N/A	DWS Full Width?	N/A
N/A	Landing Curb? (Y/N)	N/A	N/A	DWS Offset (in)	N/A
N/A	Shared Landing?	N/A			
N/A	Gutter Ponding?	N/A	N/A	Gutter Slope (%)	N/A
N/A	Gutter Lip Ht (in)	N/A	N/A	Gutter X Slope (%)	N/A
N/A	Painted X Walk1?	Yes	N/A	Painted X Walk2?	N/A
	X Walk 1 Direction	To W		X Walk 2 Direction	N/A
N/A	X Walk 1 Width (in)	108.0	N/A	X Walk 2 Width (in)	N/A
	X Walk 1 Slope (%)	3.3		X Walk 2 Slope (%)	N/A
	X Walk 1 X Slope (%)	0.7		X Walk 2 X Slope (%)	N/A

N/A	Ramp inside XWalk1?	Yes	N/A	Ramp inside XWalk2?	N/A
	Road Slope (%)	N/A	N/A	Clear Space?	N/A
	Road X Slope (%)	N/A	N/A	Clear Space to XWalk (in)	N/A
N/A	Any Obstructions?	N/A	N/A	Storm Grate/Utility Hazard?	N/A
	Obstruction Type			Storm Grate/Utility Type	
		N/A			N/A
		Yes		Surface Condition? (G/P)	Good

Remove & Replace Entire Ramp.
