Access Compliance Report

Public Rights-of-Way

(Curb Ramps)

Intersection ID: 12160	Main Street: E_9TH_ST	Cross Street: N_BREVARD_ST	Location: W
ADA ID: 7E794E51F163	Ramp Type: Perp	Initial Pass/Fail: Fail	Overall Compliance: No
Severity Score: 12.5			
Codes/Mitigation Info/Possible Solution		Field Measurements/Component Compliance

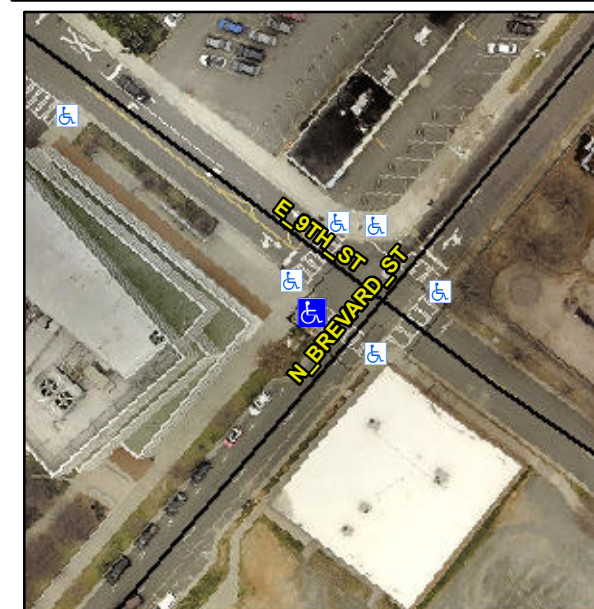
Not Found, R304.2.2

Compliance	Description	Data	Compliance	Description	Data
N/A	Ramp Length (in)	72.0	No	Ramp Slope (%)	9.3
Yes	Ramp Width (in)	48.0	Yes	Ramp XSlope (%)	0.3
N/A	Flare Type LT	N/A	N/A	Flare Type RT	N/A
N/A	Flare Slope LT (%)	N/A	N/A	Flare Slope RT (%)	N/A
N/A	Flare Traversable LT?	N/A	N/A	Flare Traversable RT?	N/A
N/A	Landing Length (in)	N/A	N/A	DWS Provided?	N/A
N/A	Landing Width (in)	N/A	N/A	DWS Contrast?	N/A
N/A	Landing Slope (%)	N/A	N/A	DWS Length (in)	N/A
N/A	Landing X Slope (%)	N/A	N/A	DWS Full Width?	N/A
N/A	Landing Curb? (Y/N)	N/A	N/A	DWS Offset (in)	N/A
N/A	Shared Landing?	N/A			
N/A	Gutter Ponding?	N/A	N/A	Gutter Slope (%)	N/A
N/A	Gutter Lip Ht (in)	N/A	N/A	Gutter X Slope (%)	N/A
N/A	Painted X Walk1?	Yes	N/A	Painted X Walk2?	N/A
	X Walk 1 Direction	To SE		X Walk 2 Direction	N/A
N/A	X Walk 1 Width (in)	104.0	N/A	X Walk 2 Width (in)	N/A
	X Walk 1 Slope (%)	1.2		X Walk 2 Slope (%)	N/A
	X Walk 1 X Slope (%)	3.2		X Walk 2 X Slope (%)	N/A

N/A	Ramp inside XWalk1?	Yes	N/A	Ramp inside XWalk2?	N/A
	Road Slope (%)	N/A	N/A	Clear Space?	N/A
	Road X Slope (%)	N/A	N/A	Clear Space to XWalk (in)	N/A
N/A	Any Obstructions?	N/A	N/A	Storm Grate/Utility Hazard?	N/A
	Obstruction Type			Storm Grate/Utility Type	
		N/A			N/A
		Yes		Surface Condition? (G/P)	Good

Possible Solutions:

Remove & Replace Entire Ramp.
