# Access Compliance Report

## Public Rights-of-Way

### (Curb Ramps)

Intersection ID: 43155	Main Street: E_W_T_HARRIS_BV	Cross Street: LINDA_LAKE_DR	Location: SE
ADA ID: 7E8D0ED5D5E8	Ramp Type: PerpDiag	Initial Pass/Fail: Fail	Overall Compliance: No
Severity Score: 12.5			
Codes/Mitigation Info/Possible Solution		Field Measurements/Component Compliance

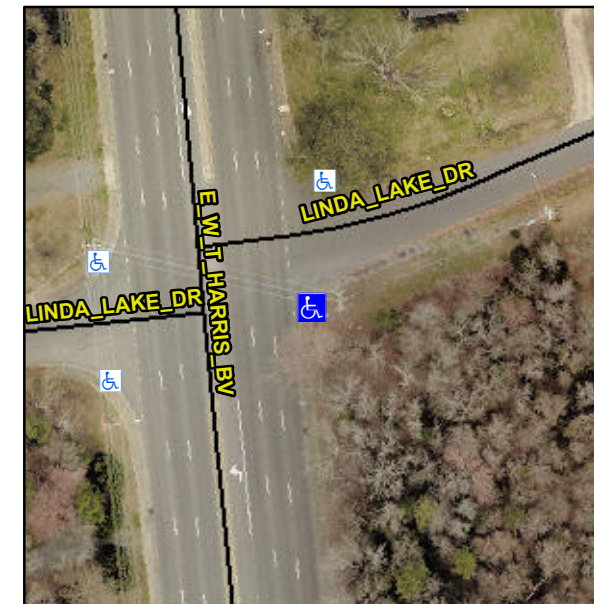
Compliance	Description	Data	Compliance	Description	Data
N/A	Ramp Length (in)	60.5	No	Ramp Slope (%)	8.7
Yes	Ramp Width (in)	48.0	Yes	Ramp XSlope (%)	1.0
N/A	Flare Type LT	N/A	N/A	Flare Type RT	N/A
N/A	Flare Slope LT (%)	N/A	N/A	Flare Slope RT (%)	N/A
N/A	Flare Traversable LT?	N/A	N/A	Flare Traversable RT?	N/A
N/A	Landing Length (in)	N/A	N/A	DWS Provided?	N/A
N/A	Landing Width (in)	N/A	N/A	DWS Contrast?	N/A
N/A	Landing Slope (%)	N/A	N/A	DWS Length (in)	N/A
N/A	Landing X Slope (%)	N/A	N/A	DWS Full Width?	N/A
N/A	Landing Curb? (Y/N)	N/A	N/A	DWS Offset (in)	N/A
N/A	Shared Landing?	N/A			
N/A	Gutter Ponding?	N/A	N/A	Gutter Slope (%)	N/A
N/A	Gutter Lip Ht (in)	N/A	N/A	Gutter X Slope (%)	N/A
N/A	Painted X Walk1?	No	N/A	Painted X Walk2?	No
	X Walk 1 Direction	To N		X Walk 2 Direction	To W
N/A	X Walk 1 Width (in)	N/A	N/A	X Walk 2 Width (in)	N/A
	X Walk 1 Slope (%)	1.1		X Walk 2 Slope (%)	0.5
	X Walk 1 X Slope (%)	1.6		X Walk 2 X Slope (%)	1.2

N/A	Ramp inside XWalk1?	N/A	N/A	Ramp inside XWalk2?	N/A
	Road Slope (%)	1.2	N/A	Clear Space?	N/A
	Road X Slope (%)	0.0	N/A	Clear Space to XWalk (in)	N/A
N/A	Any Obstructions?	N/A	N/A	Storm Grate/Utility Hazard?	N/A
	Obstruction Type			Storm Grate/Utility Type	
		N/A			N/A
		Yes		Surface Condition? (G/P)	Good

Possible Solutions:

**Remove & Replace Curb Ramp With Two New Directional Ramps or Equivalent.**

**Not Found, R304.2.2**
