## Access Compliance Report Public Rights-of-Way (Curb Ramps)

Intersection ID: 4257 Main Street: DAVID\_COX\_RD Cross Street: WESTBURY\_LAKE\_DR Location: N

ADA ID: 7E8D47A6F8EE Ramp Type: BlendTrans1 Initial Pass/Fail: Fail Overall Compliance: No Severity Score: 25

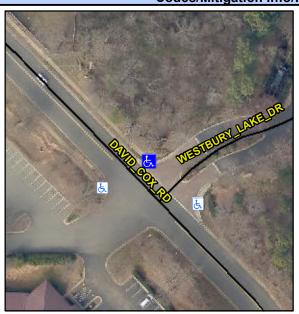
RP < 5%

Not Found, R304.5.3

Field Measurements/Component Compnance					
Compliance Description		Data	Compliance Description		Data
N/A	Ramp Length (in)	48.0	Yes	BlendTrans Slope (%)	1.6
Yes	Ramp Width (in)	48.0	No	BlendTrans XSlope (%)	12.1
N/A	Flare Type LT	N/A	N/A	Flare Type RT	N/A
N/A	Flare Slope LT (%)	N/A	N/A	Flare Slope RT (%)	N/A
N/A	Flare Traversable LT?	N/A	N/A	Flare Traversable RT?	N/A
N/A	Landing Length (in)	N/A	N/A	DWS Provided?	N/A
N/A	Landing Width (in)	N/A	N/A	DWS Contrast?	N/A
N/A	Landing Slope (%)	N/A	N/A	DWS Length (in)	N/A
N/A	Landing X Slope (%)	N/A	N/A	DWS Full Width?	N/A
N/A	Landing Curb? (Y/N)	N/A	N/A	DWS Offset (in)	N/A
N/A	Shared Landing?	N/A			
N/A	Gutter Ponding?	N/A	N/A	Gutter Slope (%)	N/A
N/A	Gutter Lip Ht (in)	N/A	N/A	Gutter X Slope (%)	N/A
N/A	Painted X Walk1?	No	N/A	Painted X Walk2?	No
	X Walk 1 Direction	To SE		X Walk 2 Direction	To SW
	X Walk 1 Width (in)	N/A		X Walk 2 Width (in)	N/A
	X Walk 1 Slope (%)	3.3		X Walk 2 Slope (%)	4.4

X Walk 1 X Slope (%)	5.2		X Walk 2 X Slope (%)	8.3
N/A	Ramp inside XWalk1?	N/A	N/A	Ramp inside XWalk2?	N/A
	Road Slope (%)	7.5		Clear Space?	N/A
	Road X Slope (%)	2.1	N/A	Clear Space to XWalk (in)	N/A
N/A	Any Obstructions?	N/A	N/A	Storm Grate/Utility Hazard?	N/A
	Obstruction Type		l	Storm Grate/Utility Type	
		N/A			N/A
			Yes	Surface Condition? (G/P)	Good

Remove & Replace Curb Ramp With Two New Directional Ramps or Equivalent.
