Access Compliance Report

Public Rights-of-Way

(Curb Ramps)

Intersection ID: 10033987	Main Street: PARK_RD	Cross Street: N/A	Location: SW
ADA ID: 7E904C1895A6	Ramp Type: Directional2	Initial Pass/Fail: Fail	Overall Compliance: No
		Severity Score: 1.25

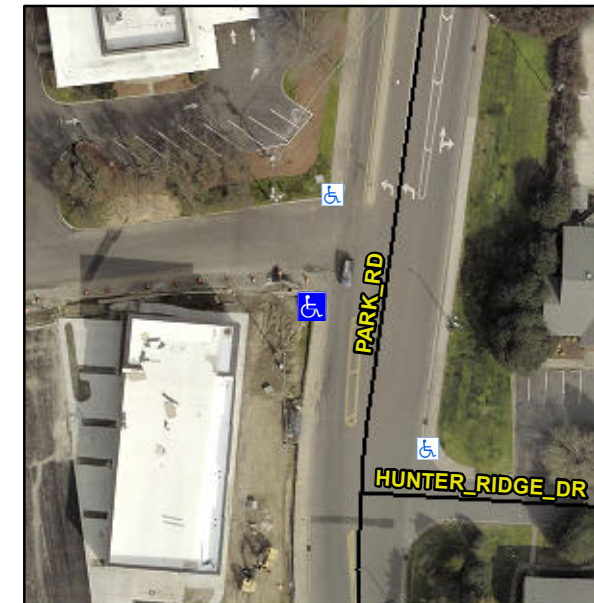
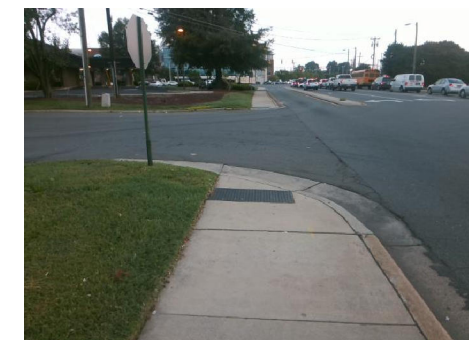
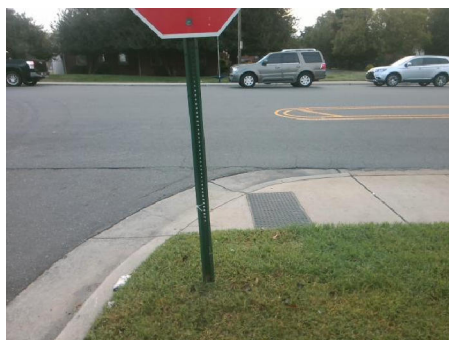
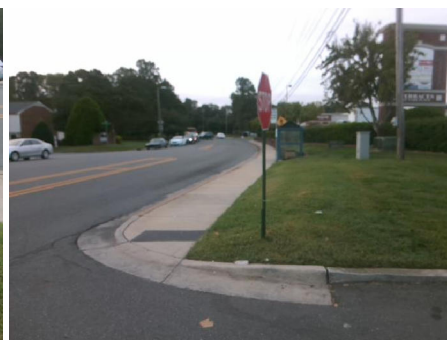
R304.5.3

Compliance	Description	Data	Compliance	Description	Data
N/A	Ramp Length (in)	64.0	N/A	Grade Break?	N/A
Yes	Ramp Width (in)	48.0	N/A	Grade Break Slope (%)	0.0
Yes	Ramp Slope (%)	1.4	N/A	Grade Break XSlope (%)	0.0
No	Ramp XSlope (%)	3.6			
N/A	Flare Type LT	N/A	N/A	Flare Type RT	N/A
N/A	Flare Slope LT (%)	N/A	N/A	Flare Slope RT (%)	0.0
N/A	Flare Traversable LT?	N/A	N/A	Flare Traversable RT?	N/A
N/A	Landing Length (in)	0.0	N/A	DWS Provided?	N/A
N/A	Landing Width (in)	0.0	N/A	DWS Contrast?	N/A
N/A	Landing Slope (%)	0.0	N/A	DWS Length (in)	N/A
N/A	Landing X Slope (%)	0.0	N/A	DWS Full Width?	N/A
N/A	Landing Curb? (Y/N)	N/A	N/A	DWS Offset LT (in)	N/A
N/A	Shared Landing?	N/A	N/A	DWS Offset RT (in)	N/A
N/A	Gutter Ponding?	0.0	N/A	Gutter Slope (%)	N/A
N/A	Gutter Lip Ht (in)	0.0	N/A	Gutter X Slope (%)	N/A
N/A	Painted X Walk1?	No		Road Slope (%)	1.1
	X Walk 1 Direction	To N		Road X Slope (%)	2.4
	X Walk 1 Width (in)	N/A		Clear Space?	N/A

X Walk 1 Slope (%)	1.1	N/A	Clear Space to XWalk (in)	N/A
	X Walk 1 X Slope (%)	2.4	N/A	Storm Grate/Utility Hazard?	N/A
N/A	Ramp inside XWalk1?	N/A		Storm Grate/Utility Type	
N/A	Any Obstructions?	N/A			N/A
	Obstruction Type		Yes	Surface Condition? (G/P)	Good
			N/A	Curb Slope (%)	12.1

Remove & Replace Entire Ramp.

Total Cost: \$ 1800.00
