Access Compliance Report

Public Rights-of-Way

(Curb Ramps)

Intersection ID: N/A	Main Street: PATIMBY_RD	Cross Street: MCALPINE_PARK_DR	Location: NW
ADA ID: 7E91E47B10E3	Ramp Type: Perp	Initial Pass/Fail: Fail	Overall Compliance: No
Severity Score: 13.75			
Codes/Mitigation Info/Possible Solution		Field Measurements/Component Compliance

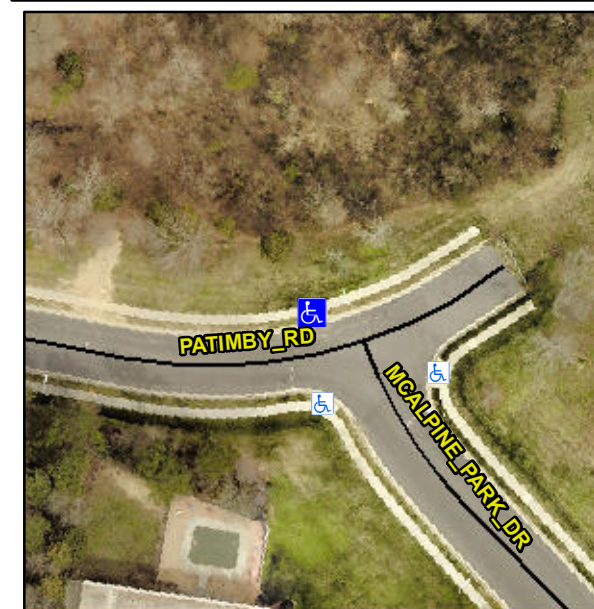
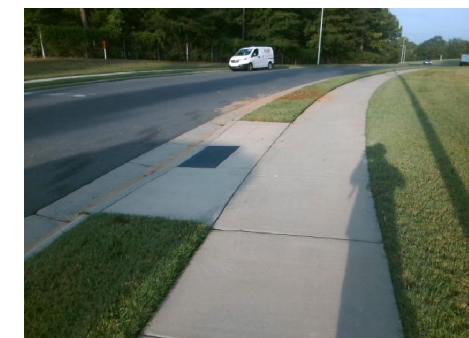
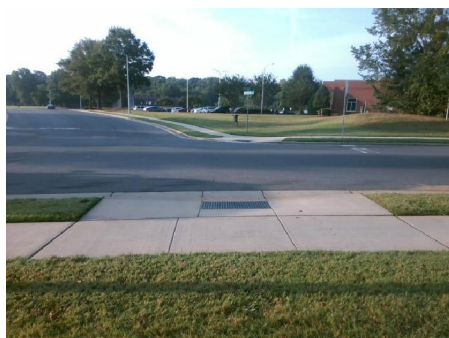
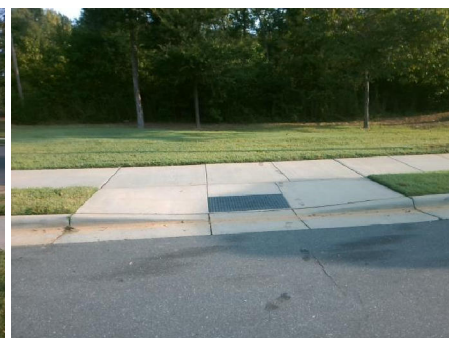
Not Found, R304.2.2, R304.5.3

Compliance	Description	Data	Compliance	Description	Data
N/A	Ramp Length (in)	47.5	No	Ramp Slope (%)	10.0
Yes	Ramp Width (in)	48.0	No	Ramp XSlope (%)	4.7
N/A	Flare Type LT	N/A	N/A	Flare Type RT	N/A
N/A	Flare Slope LT (%)	N/A	N/A	Flare Slope RT (%)	N/A
N/A	Flare Traversable LT?	N/A	N/A	Flare Traversable RT?	N/A
N/A	Landing Length (in)	N/A	N/A	DWS Provided?	N/A
N/A	Landing Width (in)	N/A	N/A	DWS Contrast?	N/A
N/A	Landing Slope (%)	N/A	N/A	DWS Length (in)	N/A
N/A	Landing X Slope (%)	N/A	N/A	DWS Full Width?	N/A
N/A	Landing Curb? (Y/N)	N/A	N/A	DWS Offset (in)	N/A
N/A	Shared Landing?	N/A			
N/A	Gutter Ponding?	N/A	N/A	Gutter Slope (%)	N/A
N/A	Gutter Lip Ht (in)	N/A	N/A	Gutter X Slope (%)	N/A
N/A	Painted X Walk1?	No	N/A	Painted X Walk2?	N/A
	X Walk 1 Direction	To S		X Walk 2 Direction	N/A
N/A	X Walk 1 Width (in)	N/A	N/A	X Walk 2 Width (in)	N/A
	X Walk 1 Slope (%)	2.3		X Walk 2 Slope (%)	N/A
	X Walk 1 X Slope (%)	3.4		X Walk 2 X Slope (%)	N/A

N/A	Ramp inside XWalk1?	N/A	N/A	Ramp inside XWalk2?	N/A
	Road Slope (%)	N/A	N/A	Clear Space?	N/A
	Road X Slope (%)	N/A	N/A	Clear Space to XWalk (in)	N/A
N/A	Any Obstructions?	N/A	N/A	Storm Grate/Utility Hazard?	N/A
	Obstruction Type			Storm Grate/Utility Type	
		N/A			N/A
		Yes		Surface Condition? (G/P)	Good

Remove & Replace Entire Ramp.

Total Cost: \$ 1850.00
