Access Compliance Report

Public Rights-of-Way

(Curb Ramps)

Intersection ID: 3514	Main Street: OVERLOOK_MOUNTAIN_DR	Cross Street: TRANQUILLITY_DR	Location:	N
ADA ID: 7E91F16AAA72	Ramp Type: Perp	Initial Pass/Fail: Fail	Overall Compliance: No	Severity Score: 8.75
Codes/Mitigation Info/Possible Solution		Field Measurements/Component Compliance

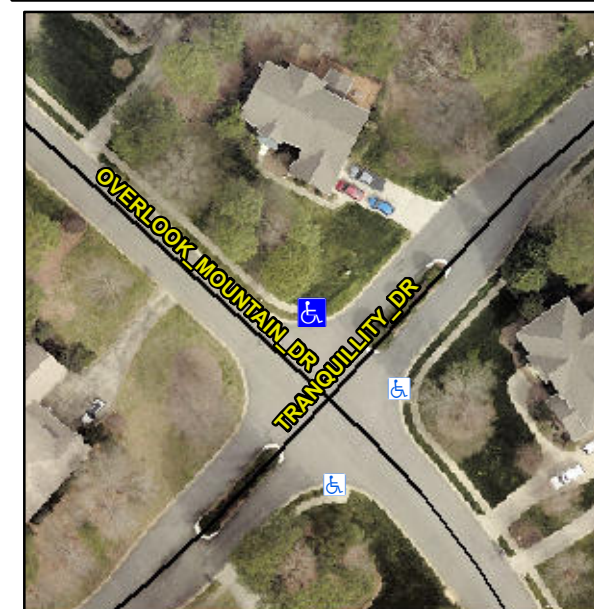
Not Found, R304.5.1

Compliance	Description	Data	Compliance	Description	Data
N/A	Ramp Length (in)	49.0	Yes	Ramp Slope (%)	7.3
No	Ramp Width (in)	45.5	Yes	Ramp XSlope (%)	1.0
N/A	Flare Type LT	N/A	N/A	Flare Type RT	N/A
N/A	Flare Slope LT (%)	N/A	N/A	Flare Slope RT (%)	N/A
N/A	Flare Traversable LT?	N/A	N/A	Flare Traversable RT?	N/A
N/A	Landing Length (in)	N/A	N/A	DWS Provided?	N/A
N/A	Landing Width (in)	N/A	N/A	DWS Contrast?	N/A
N/A	Landing Slope (%)	N/A	N/A	DWS Length (in)	N/A
N/A	Landing X Slope (%)	N/A	N/A	DWS Full Width?	N/A
N/A	Landing Curb? (Y/N)	N/A	N/A	DWS Offset (in)	N/A
N/A	Shared Landing?	N/A			
N/A	Gutter Ponding?	N/A	N/A	Gutter Slope (%)	N/A
N/A	Gutter Lip Ht (in)	N/A	N/A	Gutter X Slope (%)	N/A
N/A	Painted X Walk1?	No	N/A	Painted X Walk2?	N/A
	X Walk 1 Direction	To SE		X Walk 2 Direction	N/A
N/A	X Walk 1 Width (in)	N/A	N/A	X Walk 2 Width (in)	N/A
	X Walk 1 Slope (%)	2.1		X Walk 2 Slope (%)	N/A
	X Walk 1 X Slope (%)	1.6		X Walk 2 X Slope (%)	N/A

N/A	Ramp inside XWalk1?	N/A	N/A	Ramp inside XWalk2?	N/A
	Road Slope (%)	N/A	N/A	Clear Space?	N/A
	Road X Slope (%)	N/A	N/A	Clear Space to XWalk (in)	N/A
N/A	Any Obstructions?	N/A	N/A	Storm Grate/Utility Hazard?	N/A
	Obstruction Type			Storm Grate/Utility Type	
		N/A			N/A
			Yes	Surface Condition? (G/P)	Good

Possible Solutions:

Remove & Replace Entire Ramp.
