Access Compliance Report

Public Rights-of-Way

(Curb Ramps)

Intersection ID: 49932	Main Street: WOBURN_RD	Cross Street: PAXTON_RUN_RD	Location: NE
ADA ID: 7E946A4B8EC4	Ramp Type: Perp	Initial Pass/Fail: Fail	Overall Compliance: No
		Severity Score: 22.5

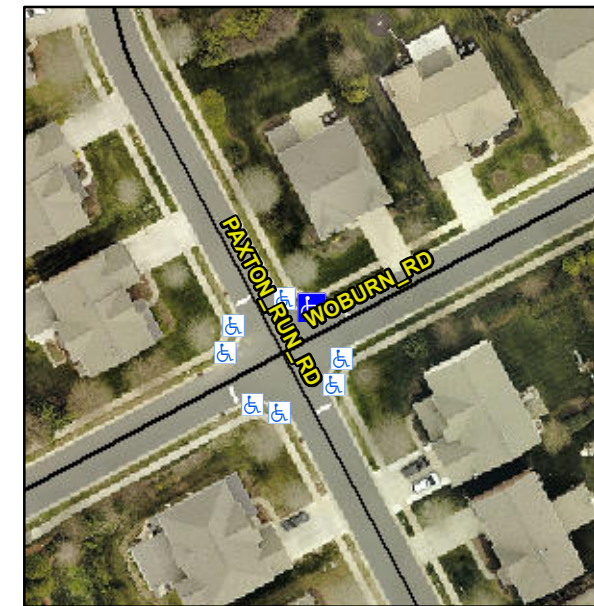
Not Found, R304.5.1, R304.2.2, R304.5.3

Compliance	Description	Data	Compliance	Description	Data
N/A	Ramp Length (in)	47.0	No	Ramp Slope (%)	10.2
No	Ramp Width (in)	47.0	No	Ramp XSlope (%)	3.2
N/A	Flare Type LT	N/A	N/A	Flare Type RT	N/A
N/A	Flare Slope LT (%)	N/A	N/A	Flare Slope RT (%)	N/A
N/A	Flare Traversable LT?	N/A	N/A	Flare Traversable RT?	N/A
N/A	Landing Length (in)	N/A	N/A	DWS Provided?	N/A
N/A	Landing Width (in)	N/A	N/A	DWS Contrast?	N/A
N/A	Landing Slope (%)	N/A	N/A	DWS Length (in)	N/A
N/A	Landing X Slope (%)	N/A	N/A	DWS Full Width?	N/A
N/A	Landing Curb? (Y/N)	N/A	N/A	DWS Offset (in)	N/A
N/A	Shared Landing?	N/A			
N/A	Gutter Ponding?	N/A	N/A	Gutter Slope (%)	N/A
N/A	Gutter Lip Ht (in)	N/A	N/A	Gutter X Slope (%)	N/A
N/A	Painted X Walk1?	No	N/A	Painted X Walk2?	N/A
	X Walk 1 Direction	To SE		X Walk 2 Direction	N/A
N/A	X Walk 1 Width (in)	N/A	N/A	X Walk 2 Width (in)	N/A
	X Walk 1 Slope (%)	1.0		X Walk 2 Slope (%)	N/A
	X Walk 1 X Slope (%)	4.0		X Walk 2 X Slope (%)	N/A

N/A	Ramp inside XWalk1?	N/A	N/A	Ramp inside XWalk2?	N/A
	Road Slope (%)	N/A	N/A	Clear Space?	N/A
	Road X Slope (%)	N/A	N/A	Clear Space to XWalk (in)	N/A
N/A	Any Obstructions?	N/A	N/A	Storm Grate/Utility Hazard?	N/A
	Obstruction Type			Storm Grate/Utility Type	
		N/A			N/A
			Yes	Surface Condition? (G/P)	Good

Remove & Replace Entire Ramp.
