Access Compliance Report

Public Rights-of-Way

(Curb Ramps)

Intersection ID: 10028420	Main Street: HIGHGROVE_ST	Cross Street: N/A	Location: SW
ADA ID: 7E9C4E4A1015	Ramp Type: PerpDiag	Initial Pass/Fail: Fail	Overall Compliance: No
		Severity Score: 25

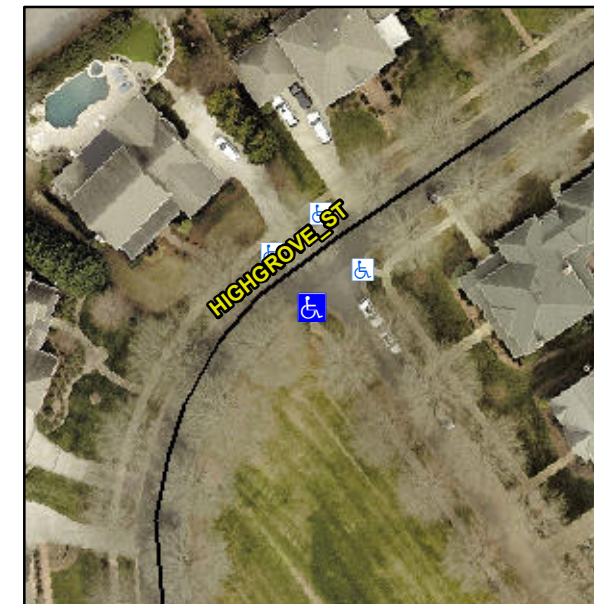
Compliance	Description	Data	Compliance	Description	Data
N/A	Ramp Length (in)	92.0	No	Ramp Slope (%)	9.6
Yes	Ramp Width (in)	55.0	No	Ramp XSlope (%)	6.2
N/A	Flare Type LT	N/A	N/A	Flare Type RT	N/A
N/A	Flare Slope LT (%)	N/A	N/A	Flare Slope RT (%)	N/A
N/A	Flare Traversable LT?	N/A	N/A	Flare Traversable RT?	N/A
N/A	Landing Length (in)	N/A	N/A	DWS Provided?	N/A
N/A	Landing Width (in)	N/A	N/A	DWS Contrast?	N/A
N/A	Landing Slope (%)	N/A	N/A	DWS Length (in)	N/A
N/A	Landing X Slope (%)	N/A	N/A	DWS Full Width?	N/A
N/A	Landing Curb? (Y/N)	N/A	N/A	DWS Offset (in)	N/A
N/A	Shared Landing?	N/A			
N/A	Gutter Ponding?	N/A	N/A	Gutter Slope (%)	N/A
N/A	Gutter Lip Ht (in)	N/A	N/A	Gutter X Slope (%)	N/A
N/A	Painted X Walk1?	No	N/A	Painted X Walk2?	No
	X Walk 1 Direction	To NE		X Walk 2 Direction	To N
N/A	X Walk 1 Width (in)	N/A	N/A	X Walk 2 Width (in)	N/A
	X Walk 1 Slope (%)	2.8		X Walk 2 Slope (%)	6.0
	X Walk 1 X Slope (%)	3.2		X Walk 2 X Slope (%)	4.4

N/A	Ramp inside XWalk1?	N/A	N/A	Ramp inside XWalk2?	N/A
	Road Slope (%)	7.3	N/A	Clear Space?	N/A
	Road X Slope (%)	1.9	N/A	Clear Space to XWalk (in)	N/A
N/A	Any Obstructions?	N/A	N/A	Storm Grate/Utility Hazard?	N/A
	Obstruction Type			Storm Grate/Utility Type	
		N/A			N/A
			Yes	Surface Condition? (G/P)	Good

Remove & Replace Curb Ramp With Two New Directional Ramps or Equivalent.
