Access Compliance Report

Public Rights-of-Way

(Curb Ramps)

Intersection ID: 30319	Main Street: HUNTER_FOREST_CT	Cross Street: HIDDEN_FOREST_DR	Location: SW
ADA ID: 7E9E964252AC	Ramp Type: PerpDiag	Initial Pass/Fail: Pass	Overall Compliance: No
		Severity Score: 25

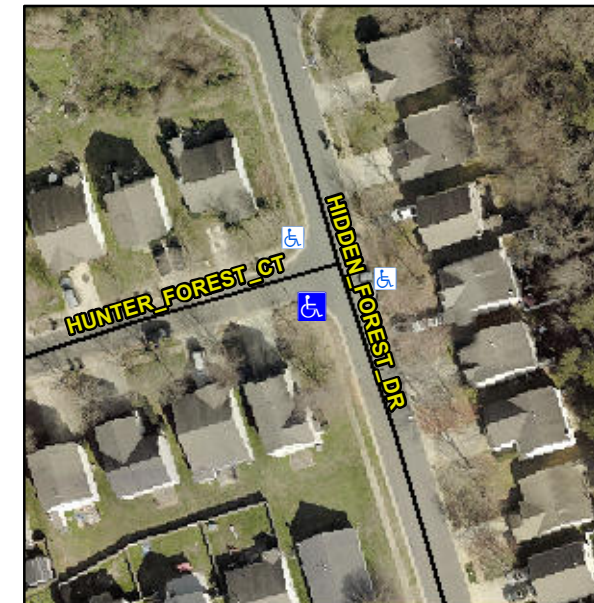
Not Found, R304.2.1, R304.2.2-Perp, R304.3.2-Para, R305, R302.7.2, R304.5.3

Compliance	Description	Data	Compliance	Description	Data
N/A	Ramp Length (in)	49.0	Yes	Ramp Slope (%)	5.6
Yes	Ramp Width (in)	55.0	Yes	Ramp XSlope (%)	0.7
N/A	Flare Type LT	Sloped	N/A	Flare Type RT	N/A
N/A	Flare Slope LT (%)	4.2	N/A	Flare Slope RT (%)	2.5
N/A	Flare Traversable LT?	No	N/A	Flare Traversable RT?	No
No	Landing Length (in)	44.5	No	DWS Provided?	No
Yes	Landing Width (in)	55.0	N/A	DWS Contrast?	No
No	Landing Slope (%)	5.3	N/A	DWS Length (in)	N/A
Yes	Landing X Slope (%)	1.5	N/A	DWS Full Width?	No
N/A	Landing Curb? (Y/N)	No	N/A	DWS Offset (in)	N/A
N/A	Shared Landing?	No			
Yes	Gutter Ponding?	No	Yes	Gutter Slope (%)	3.6
No	Gutter Lip Ht (in)	1.0	No	Gutter X Slope (%)	3.5
N/A	Painted X Walk1?	No	N/A	Painted X Walk2?	No
	X Walk 1 Direction	To E		X Walk 2 Direction	To N
N/A	X Walk 1 Width (in)	N/A	N/A	X Walk 2 Width (in)	N/A
	X Walk 1 Slope (%)	3.5		X Walk 2 Slope (%)	0.7
	X Walk 1 X Slope (%)	0.0		X Walk 2 X Slope (%)	2.7

N/A	Ramp inside XWalk1?	N/A	N/A	Ramp inside XWalk2?	N/A
	Road Slope (%)	1.6	N/A	Clear Space?	Yes
	Road X Slope (%)	2.5	N/A	Clear Space to XWalk (in)	N/A
Yes	Any Obstructions?	No	Yes	Storm Grate/Utility Hazard?	No
	Obstruction Type			Storm Grate/Utility Type	
		N/A			N/A
			Yes	Surface Condition? (G/P)	Good

Remove & Replace Curb Ramp With Two New Directional Ramps or Equivalent. Remove & Replace Gutter.
