Access Compliance Report

Public Rights-of-Way

(Curb Ramps)

Intersection ID: 10664	Main Street: CHARLES_AV	Cross Street: CLEMSON_AV	Location: SW
ADA ID: 7EAB76BF8030	Ramp Type: PerpDiag	Initial Pass/Fail: Fail	Overall Compliance: No
		Severity Score: 25

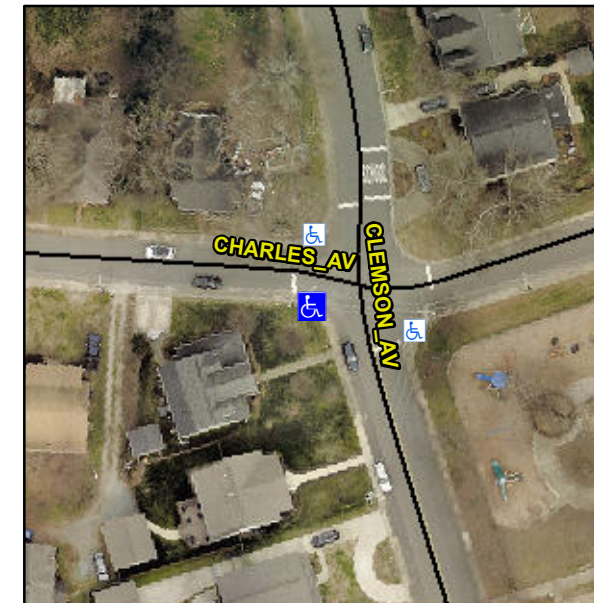
Compliance	Description	Data	Compliance	Description	Data
N/A	Ramp Length (in)	40.0	No	Ramp Slope (%)	14.7
Yes	Ramp Width (in)	50.0	Yes	Ramp XSlope (%)	0.2
N/A	Flare Type LT	N/A	N/A	Flare Type RT	N/A
N/A	Flare Slope LT (%)	N/A	N/A	Flare Slope RT (%)	N/A
N/A	Flare Traversable LT?	N/A	N/A	Flare Traversable RT?	N/A
N/A	Landing Length (in)	N/A	N/A	DWS Provided?	N/A
N/A	Landing Width (in)	N/A	N/A	DWS Contrast?	N/A
N/A	Landing Slope (%)	N/A	N/A	DWS Length (in)	N/A
N/A	Landing X Slope (%)	N/A	N/A	DWS Full Width?	N/A
N/A	Landing Curb? (Y/N)	N/A	N/A	DWS Offset (in)	N/A
N/A	Shared Landing?	N/A			
N/A	Gutter Ponding?	N/A	N/A	Gutter Slope (%)	N/A
N/A	Gutter Lip Ht (in)	N/A	N/A	Gutter X Slope (%)	N/A
N/A	Painted X Walk1?	No	N/A	Painted X Walk2?	No
	X Walk 1 Direction	To SE		X Walk 2 Direction	To N
N/A	X Walk 1 Width (in)	N/A	N/A	X Walk 2 Width (in)	N/A
	X Walk 1 Slope (%)	2.6		X Walk 2 Slope (%)	0.4
	X Walk 1 X Slope (%)	2.2		X Walk 2 X Slope (%)	2.2

Remove & Replace Curb Ramp With Two New Directional Ramps or Equivalent.
