Access Compliance Report

Public Rights-of-Way

(Curb Ramps)

Intersection ID: 30021	Main Street: DAY_LILLY_LN	Cross Street: SUMMER_MEADOW_CT	Location: SE
ADA ID: 7EB52BCBE698	Ramp Type: PerpDiag	Initial Pass/Fail: Fail	Overall Compliance: No
Severity Score: 21.25			
Codes/Mitigation Info/Possible Solution		Field Measurements/Component Compliance

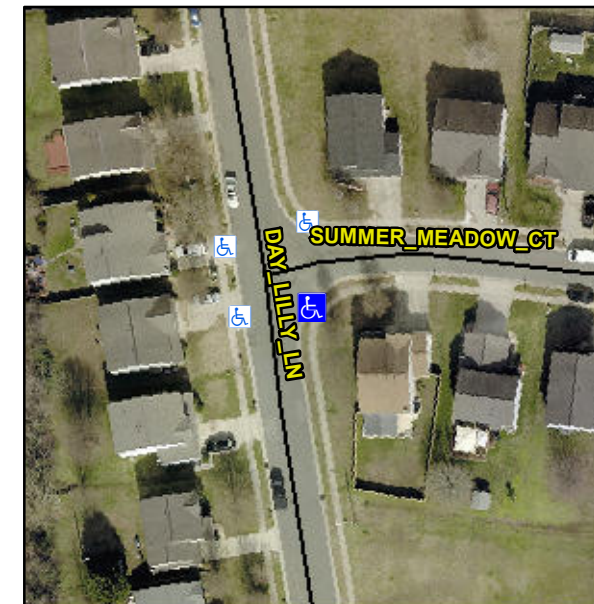
Not Found, R304.5.1, R304.2.2

Compliance	Description	Data	Compliance	Description	Data
N/A	Ramp Length (in)	47.5	No	Ramp Slope (%)	8.4
No	Ramp Width (in)	46.5	Yes	Ramp XSlope (%)	1.3
N/A	Flare Type LT	N/A	N/A	Flare Type RT	N/A
N/A	Flare Slope LT (%)	N/A	N/A	Flare Slope RT (%)	N/A
N/A	Flare Traversable LT?	N/A	N/A	Flare Traversable RT?	N/A
N/A	Landing Length (in)	N/A	N/A	DWS Provided?	N/A
N/A	Landing Width (in)	N/A	N/A	DWS Contrast?	N/A
N/A	Landing Slope (%)	N/A	N/A	DWS Length (in)	N/A
N/A	Landing X Slope (%)	N/A	N/A	DWS Full Width?	N/A
N/A	Landing Curb? (Y/N)	N/A	N/A	DWS Offset (in)	N/A
N/A	Shared Landing?	N/A			
N/A	Gutter Ponding?	N/A	N/A	Gutter Slope (%)	N/A
N/A	Gutter Lip Ht (in)	N/A	N/A	Gutter X Slope (%)	N/A
N/A	Painted X Walk1?	No	N/A	Painted X Walk2?	No
	X Walk 1 Direction	To NW		X Walk 2 Direction	To NE
N/A	X Walk 1 Width (in)	N/A	N/A	X Walk 2 Width (in)	N/A
	X Walk 1 Slope (%)	2.6		X Walk 2 Slope (%)	1.4
	X Walk 1 X Slope (%)	3.2		X Walk 2 X Slope (%)	4.3

N/A	Ramp inside XWalk1?	N/A	N/A	Ramp inside XWalk2?	N/A
	Road Slope (%)	0.7	N/A	Clear Space?	N/A
	Road X Slope (%)	5.9	N/A	Clear Space to XWalk (in)	N/A
N/A	Any Obstructions?	N/A	N/A	Storm Grate/Utility Hazard?	N/A
	Obstruction Type			Storm Grate/Utility Type	
		N/A			N/A
		Yes		Surface Condition? (G/P)	Good

Remove & Replace Curb Ramp With Two New Directional Ramps or Equivalent.
