Access Compliance Report

Public Rights-of-Way

(Curb Ramps)

Intersection ID: 13586	Main Street: E_7TH_ST	Cross Street: ARMORY_DR	Location: W
ADA ID: 7EBBCF85E651	Ramp Type: Directional1	Initial Pass/Fail: Pass	Overall Compliance: No
		Severity Score: 17.5

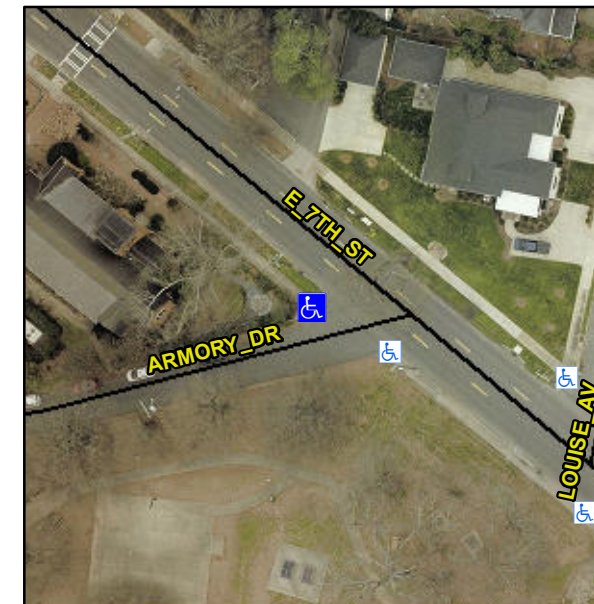
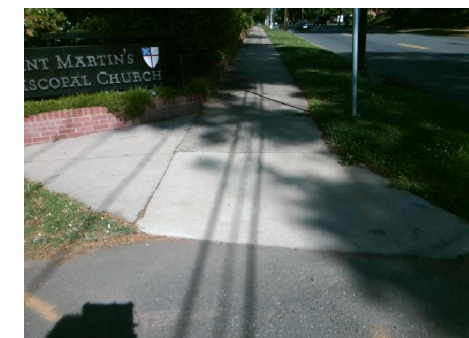
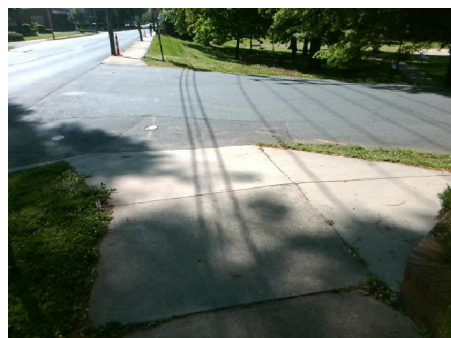
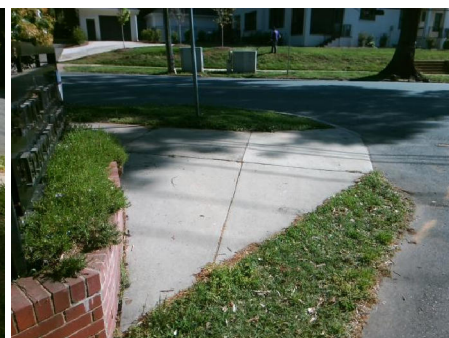
Compliance	Description	Data	Compliance	Description	Data
N/A	Ramp Length (in)	64.0	No	Grade Break?	No
Yes	Ramp Width (in)	63.0	N/A	Grade Break Slope (%)	N/A
Yes	Ramp Slope (%)	6.1	N/A	Grade Break XSlope (%)	N/A
Yes	Ramp XSlope (%)	1.2			
N/A	Flare Type LT	N/A	N/A	Flare Type RT	N/A
Yes	Flare Slope LT (%)	3.7	N/A	Flare Slope RT (%)	5.8
N/A	Flare Traversable LT?	Yes	N/A	Flare Traversable RT?	No
Yes	Landing Length (in)	60.0	No	DWS Provided?	No
Yes	Landing Width (in)	69.5	N/A	DWS Contrast?	No
No	Landing Slope (%)	2.9	N/A	DWS Length (in)	N/A
No	Landing X Slope (%)	2.4	N/A	DWS Full Width?	No
N/A	Landing Curb? (Y/N)	N/A	N/A	DWS Offset LT (in)	N/A
N/A	Shared Landing?	No	N/A	DWS Offset RT (in)	N/A
Yes	Gutter Ponding?	No	Yes	Gutter Slope (%)	1.3
No	Gutter Lip Ht (in)	0.3	Yes	Gutter X Slope (%)	0.2
N/A	Painted X Walk1?	No		Road Slope (%)	2.5
	X Walk 1 Direction	To SE		Road X Slope (%)	2.1
	X Walk 1 Width (in)	N/A		Clear Space?	Yes

X Walk 1 Slope (%)	2.5	N/A	Clear Space to XWalk (in)	N/A
	X Walk 1 X Slope (%)	2.1	Yes	Storm Grate/Utility Hazard?	No
N/A	Ramp inside XWalk1?	N/A		Storm Grate/Utility Type	
Yes	Any Obstructions?	No			N/A
	Obstruction Type		Yes	Surface Condition? (G/P)	Good
			N/A	Curb Slope (%)	4.5

**Remove & Replace Entire Ramp.
Grind Gutter Lip.**

**R304.2.2-Perp, R304.3.2-Para,
R304.5.3, R304.5.2, R305, R302.7.2**

Total Cost: \$ 1800.00
