Access Compliance Report

Public Rights-of-Way

(Curb Ramps)

Intersection ID: 48948	Main Street: BIRCHLEY_CR	Cross Street: DAVID_JENNINGS_AV	Location: S
ADA ID: 7EBFE3F4F1DA	Ramp Type: Perp	Initial Pass/Fail: Pass	Overall Compliance: No
Severity Score: 5			
Codes/Mitigation Info/Possible Solution		Field Measurements/Component Compliance

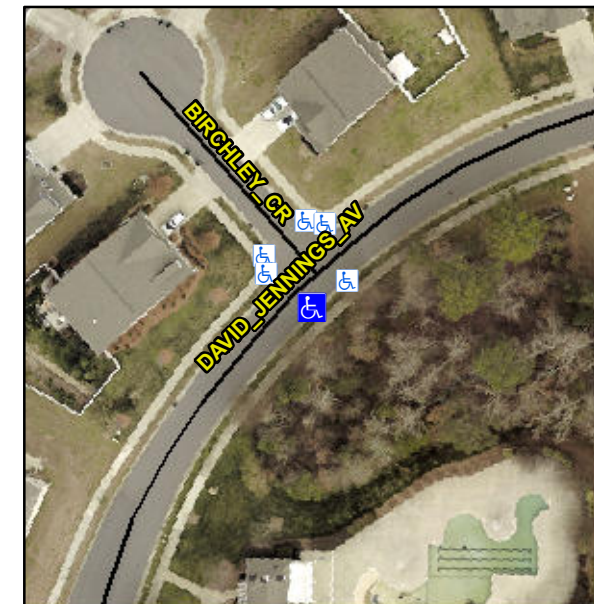
Not Found, R304.5.4, R304.5.3

Compliance	Description	Data	Compliance	Description	Data
N/A	Ramp Length (in)	47.0	Yes	Ramp Slope (%)	5.6
Yes	Ramp Width (in)	48.0	Yes	Ramp XSlope (%)	1.8
N/A	Flare Type LT	Sloped	N/A	Flare Type RT	N/A
N/A	Flare Slope LT (%)	0.5	N/A	Flare Slope RT (%)	5.0
N/A	Flare Traversable LT?	No	N/A	Flare Traversable RT?	No
Yes	Landing Length (in)	59.5	Yes	DWS Provided?	Yes
Yes	Landing Width (in)	48.0	Yes	DWS Contrast?	Yes
Yes	Landing Slope (%)	1.6	Yes	DWS Length (in)	24.5
Yes	Landing X Slope (%)	1.7	Yes	DWS Full Width?	Yes
N/A	Landing Curb? (Y/N)	No	Yes	DWS Offset (in)	0.5
N/A	Shared Landing?	No			
Yes	Gutter Ponding?	No	No	Gutter Slope (%)	9.0
Yes	Gutter Lip Ht (in)	0.0	No	Gutter X Slope (%)	3.6
N/A	Painted X Walk1?	No	N/A	Painted X Walk2?	N/A
	X Walk 1 Direction	To NW		X Walk 2 Direction	N/A
N/A	X Walk 1 Width (in)	N/A	N/A	X Walk 2 Width (in)	N/A
	X Walk 1 Slope (%)	3.3		X Walk 2 Slope (%)	N/A
	X Walk 1 X Slope (%)	3.0		X Walk 2 X Slope (%)	N/A

N/A	Ramp inside XWalk1?	N/A	N/A	Ramp inside XWalk2?	N/A
	Road Slope (%)	N/A	N/A	Clear Space?	Yes
	Road X Slope (%)	N/A	N/A	Clear Space to XWalk (in)	N/A
Yes	Any Obstructions?	No	Yes	Storm Grate/Utility Hazard?	No
	Obstruction Type			Storm Grate/Utility Type	
		N/A			N/A
			Yes	Surface Condition? (G/P)	Good

Possible Solutions:

**Remove & Replace Entire Ramp.
Remove & Replace Gutter.**
