# Access Compliance Report

## Public Rights-of-Way

| Intersection ID: 46346 | Main Street: MEADOW_KNOLL_DR | Cross Street: MINT_THISTLE_CT | Location: W |
| ADA ID: 7EC4765B370D | Ramp Type: BlendTrans1 | Initial Pass/Fail: Fail | Overall Compliance: No |

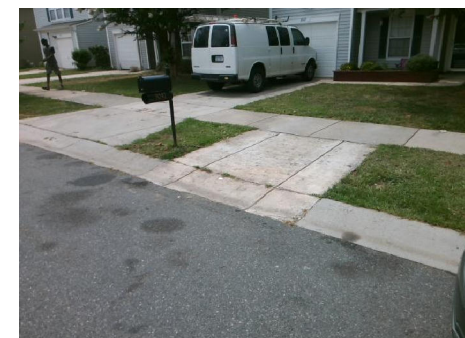
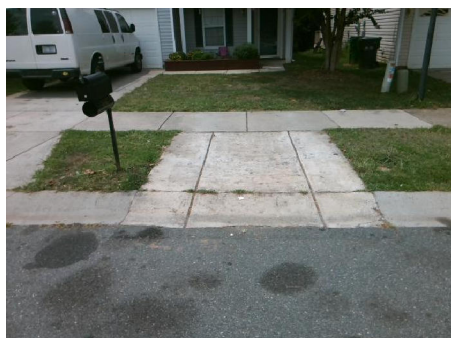
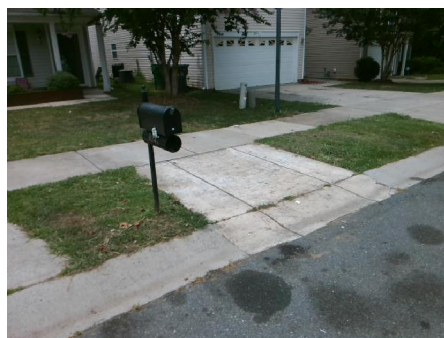
**CURB GAP 1.0**

**Not Found, R304.5.1**

| Compliance | Description | Data | Compliance | Description | Data |
|---|---|---|---|---|---|
| No | Ramp Width (in) | 47.5 | Yes | BlendTrans XSlope (%) | 1.2 |
| | | | No | Curb Slope (%) | 15.3 |

**Remove & Replace Curb Ramp With Two New Directional Ramps or Equivalent.**
