Access Compliance Report

Public Rights-of-Way

(Curb Ramps)

Intersection ID: 31891	Main Street: CENTERLINE_DR	Cross Street: MOUNTAIN_SPRINGS_DR	Location: NE
ADA ID: 7EC6E0C664F5	Ramp Type: BlendTrans1	Initial Pass/Fail: Fail	Overall Compliance: No
Codes/Mitigation Info/Possible Solution		Field Measurements/Component Compliance	
Severity Score: 8.75

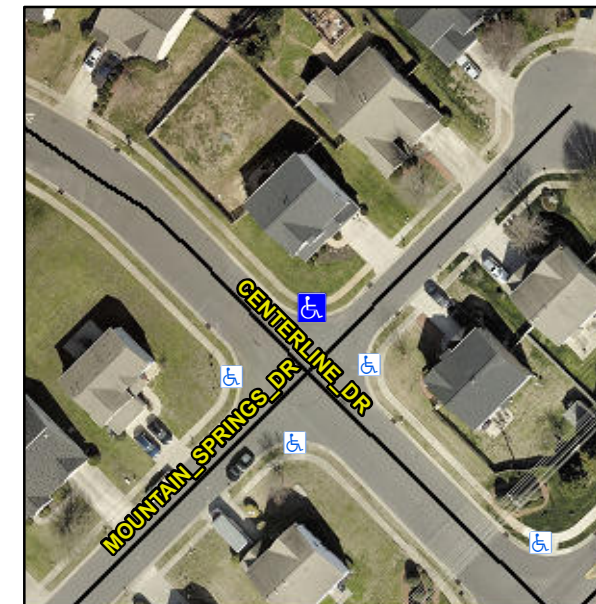
Compliance	Description	Data	Compliance	Description	Data
N/A	Ramp Length (in)	47.5	Yes	BlendTrans Slope (%)	3.9
No	Ramp Width (in)	38.5	Yes	BlendTrans XSlope (%)	0.9
N/A	Flare Type LT	N/A	N/A	Flare Type RT	N/A
N/A	Flare Slope LT (%)	N/A	N/A	Flare Slope RT (%)	N/A
N/A	Flare Traversable LT?	N/A	N/A	Flare Traversable RT?	N/A
N/A	Landing Length (in)	N/A	N/A	DWS Provided?	N/A
N/A	Landing Width (in)	N/A	N/A	DWS Contrast?	N/A
N/A	Landing Slope (%)	N/A	N/A	DWS Length (in)	N/A
N/A	Landing X Slope (%)	N/A	N/A	DWS Full Width?	N/A
N/A	Landing Curb? (Y/N)	N/A	N/A	DWS Offset (in)	N/A
N/A	Shared Landing?	N/A			
N/A	Gutter Ponding?	N/A	N/A	Gutter Slope (%)	N/A
N/A	Gutter Lip Ht (in)	N/A	N/A	Gutter X Slope (%)	N/A
N/A	Painted X Walk1?	No	N/A	Painted X Walk2?	No
	X Walk 1 Direction	To SW		X Walk 2 Direction	To SE
	X Walk 1 Width (in)	N/A		X Walk 2 Width (in)	N/A
	X Walk 1 Slope (%)	1.3		X Walk 2 Slope (%)	0.6
	X Walk 1 X Slope (%)	1.7		X Walk 2 X Slope (%)	1.5

N/A	Ramp inside XWalk1?	N/A	N/A	Ramp inside XWalk2?	N/A
	Road Slope (%)	1.1		Clear Space?	N/A
	Road X Slope (%)	0.3	N/A	Clear Space to XWalk (in)	N/A
N/A	Any Obstructions?	N/A	N/A	Storm Grate/Utility Hazard?	N/A
	Obstruction Type			Storm Grate/Utility Type	
		N/A			N/A
			Yes	Surface Condition? (G/P)	Good
			No	Curb Slope (%)	9.9

Possible Solutions:

Remove & Replace Curb Ramp With Two New Directional Ramps or Equivalent.

Not Found, R304.5.1

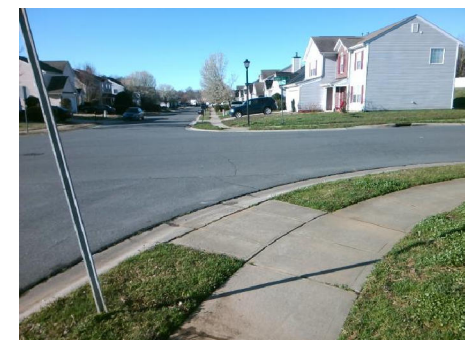
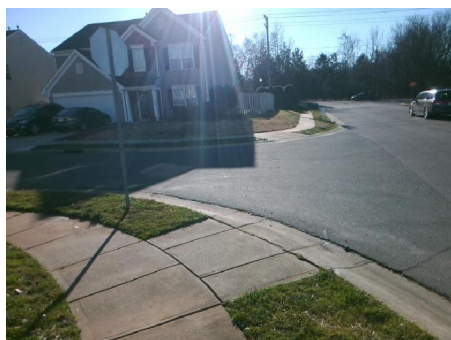
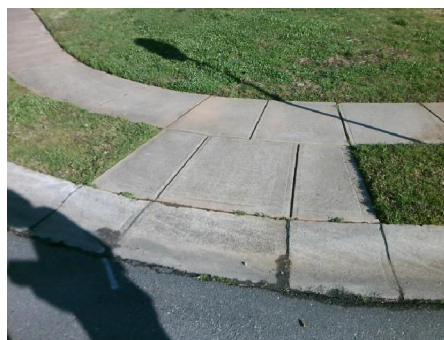
Street 1 Name **CENTERLINE DR**
 Stop Condition-Street 1 **None**
 Street 2 Name **MOUNTAIN SPRINGS DR**
 Stop Condition-Street 2 **StopSign**
