Access Compliance Report

Public Rights-of-Way

(Curb Ramps)

Intersection ID: N/A	Main Street: HARGROVE_AV	Cross Street: N/A	Location: SW
ADA ID: 7ED968A9C0FF	Ramp Type: PerpDiag	Initial Pass/Fail: Fail	Overall Compliance: No
Severity Score: 25			
Codes/Mitigation Info/Possible Solution		Field Measurements/Component Compliance

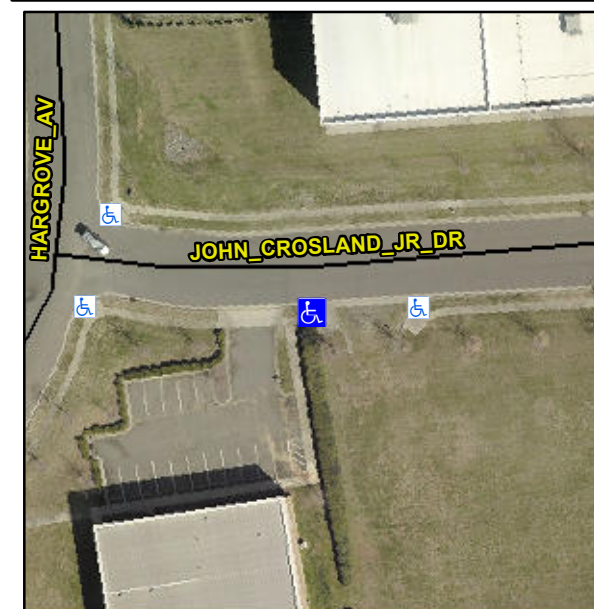
Compliance	Description	Data	Compliance	Description	Data
N/A	Ramp Length (in)	60.0	Yes	Ramp Slope (%)	7.2
Yes	Ramp Width (in)	54.0	No	Ramp XSlope (%)	7.8
N/A	Flare Type LT	N/A	N/A	Flare Type RT	N/A
N/A	Flare Slope LT (%)	N/A	N/A	Flare Slope RT (%)	N/A
N/A	Flare Traversable LT?	No	N/A	Flare Traversable RT?	No
N/A	Landing Length (in)	N/A	N/A	DWS Provided?	N/A
N/A	Landing Width (in)	N/A	N/A	DWS Contrast?	N/A
N/A	Landing Slope (%)	N/A	N/A	DWS Length (in)	N/A
N/A	Landing X Slope (%)	N/A	N/A	DWS Full Width?	N/A
N/A	Landing Curb? (Y/N)	N/A	N/A	DWS Offset (in)	N/A
N/A	Shared Landing?	N/A			
N/A	Gutter Ponding?	N/A	N/A	Gutter Slope (%)	N/A
N/A	Gutter Lip Ht (in)	N/A	N/A	Gutter X Slope (%)	N/A
N/A	Painted X Walk1?	No	N/A	Painted X Walk2?	No
	X Walk 1 Direction	To E		X Walk 2 Direction	To N
N/A	X Walk 1 Width (in)	N/A	N/A	X Walk 2 Width (in)	N/A
	X Walk 1 Slope (%)	N/A		X Walk 2 Slope (%)	2.5
	X Walk 1 X Slope (%)	N/A		X Walk 2 X Slope (%)	2.3

N/A	Ramp inside XWalk1?	N/A	N/A	Ramp inside XWalk2?	N/A
	Road Slope (%)	6.3	N/A	Clear Space?	N/A
	Road X Slope (%)	2.8	N/A	Clear Space to XWalk (in)	N/A
N/A	Any Obstructions?	N/A	N/A	Storm Grate/Utility Hazard?	N/A
	Obstruction Type			Storm Grate/Utility Type	
		N/A			N/A
		Yes		Surface Condition? (G/P)	Good

Possible Solutions:

Remove & Replace Curb Ramp With Two New Directional Ramps or Equivalent.

R304.5.3

\$ 3200.00
