Access Compliance Report

Public Rights-of-Way

(Curb Ramps)

Intersection ID: 44688	Main Street: MAPLE_TREE_CT	Cross Street: GENTLE_STREAM_LN	Location: SW
ADA ID: 7EF59C49E843	Ramp Type: PerpDiag	Initial Pass/Fail: Fail	Overall Compliance: No
Severity Score: 12.5			
Codes/Mitigation Info/Possible Solution		Field Measurements/Component Compliance

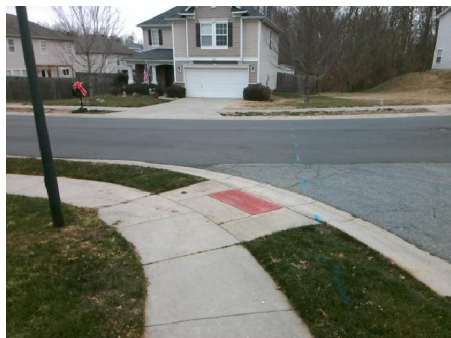
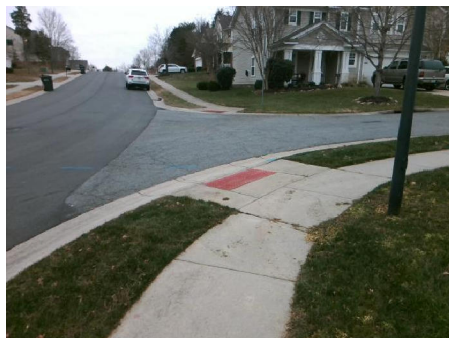
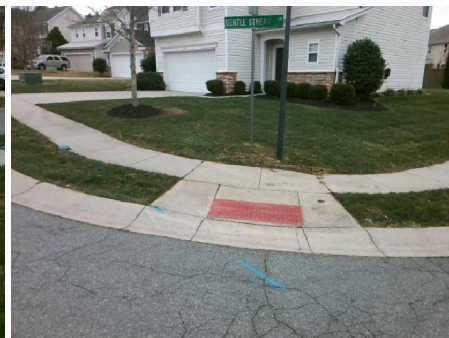
Street 1 Name MAPLE TREE CT
 Stop Condition-Street 2 StopSign
 Street 2 Name GENTLE STREAM LN
 Stop Condition-Street 1 None
