# Access Compliance Report

## Public Rights-of-Way

### (Curb Ramps)

| Intersection ID: 10041631 | Main Street: WHITEHALL_PARK_DR | Cross Street: N/A | Location: | N |

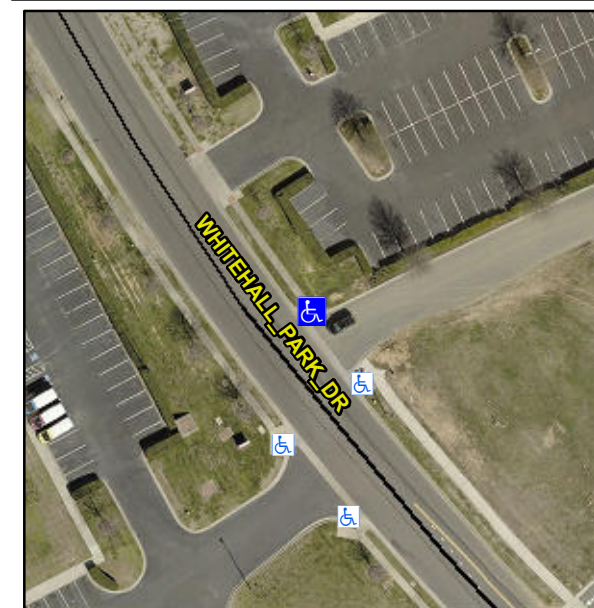
**R304.5.3**

| Compliance | Description | Data | Compliance | Description | Data |
|---|---|---|---|---|---|
| No | Ramp XSlope (%) | 7.2 | | | |

**Remove & Replace Entire Ramp.**
