Access Compliance Report

Public Rights-of-Way

(Curb Ramps)

Intersection ID: 19068	Main Street: CRESTBROOK_DR	Cross Street: RANDOLPH_RD	Location:	S
ADA ID: 7F099E72D774	Ramp Type: PerpDiag	Initial Pass/Fail: Fail	Overall Compliance: No	Severity Score: 25
Codes/Mitigation Info/Possible Solution		Field Measurements/Component Compliance

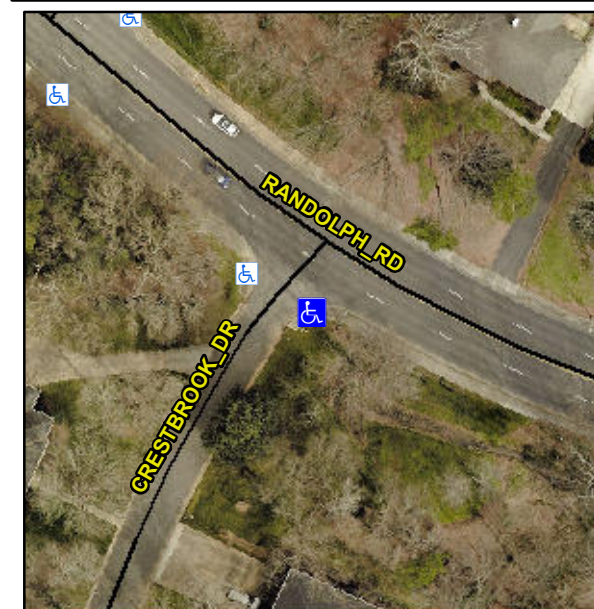
Not Found, R304.5.3

Compliance	Description	Data	Compliance	Description	Data
N/A	Ramp Length (in)	58.0	Yes	Ramp Slope (%)	5.5
Yes	Ramp Width (in)	48.0	No	Ramp XSlope (%)	7.5
N/A	Flare Type LT	N/A	N/A	Flare Type RT	N/A
N/A	Flare Slope LT (%)	N/A	N/A	Flare Slope RT (%)	N/A
N/A	Flare Traversable LT?	N/A	N/A	Flare Traversable RT?	N/A
N/A	Landing Length (in)	N/A	N/A	DWS Provided?	N/A
N/A	Landing Width (in)	N/A	N/A	DWS Contrast?	N/A
N/A	Landing Slope (%)	N/A	N/A	DWS Length (in)	N/A
N/A	Landing X Slope (%)	N/A	N/A	DWS Full Width?	N/A
N/A	Landing Curb? (Y/N)	N/A	N/A	DWS Offset (in)	N/A
N/A	Shared Landing?	N/A			
N/A	Gutter Ponding?	N/A	N/A	Gutter Slope (%)	N/A
N/A	Gutter Lip Ht (in)	N/A	N/A	Gutter X Slope (%)	N/A
N/A	Painted X Walk1?	No	N/A	Painted X Walk2?	No
	X Walk 1 Direction	To NE		X Walk 2 Direction	To NW
N/A	X Walk 1 Width (in)	N/A	N/A	X Walk 2 Width (in)	N/A
	X Walk 1 Slope (%)	2.4		X Walk 2 Slope (%)	4.1
	X Walk 1 X Slope (%)	3.4		X Walk 2 X Slope (%)	5.2

N/A	Ramp inside XWalk1?	N/A	N/A	Ramp inside XWalk2?	N/A
	Road Slope (%)	7.0	N/A	Clear Space?	N/A
	Road X Slope (%)	0.0	N/A	Clear Space to XWalk (in)	N/A
N/A	Any Obstructions?	N/A	N/A	Storm Grate/Utility Hazard?	N/A
	Obstruction Type			Storm Grate/Utility Type	
		N/A			N/A
		Yes		Surface Condition? (G/P)	Good

Remove & Replace Curb Ramp With Two New Directional Ramps or Equivalent.
