# Access Compliance Report

## Public Rights-of-Way

### (Curb Ramps)

Intersection ID: N/A	Main Street: MARGIE_ANN_DR	Cross Street: ARLYN_CIR	Location: E
ADA ID: 7F0D16BD81B7	Ramp Type: Perp	Initial Pass/Fail: Fail	Overall Compliance: No
		Severity Score: 25

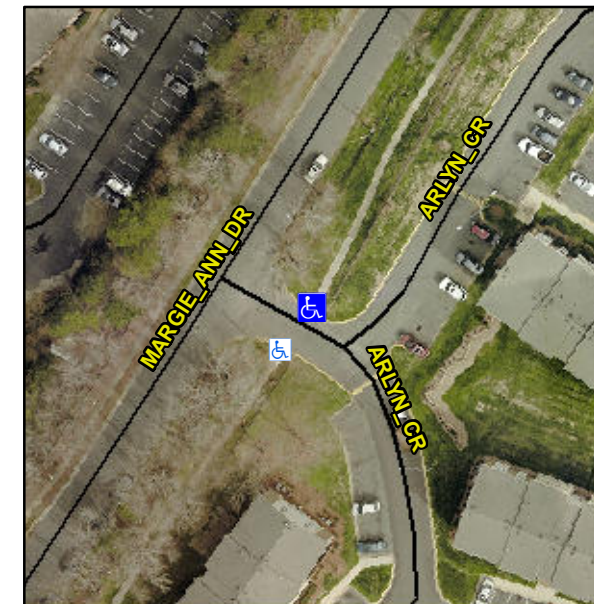
**Not Found, R304.2.2**

Compliance	Description	Data	Compliance	Description	Data
N/A	Ramp Length (in)	60.0	No	Ramp Slope (%)	15.1
Yes	Ramp Width (in)	48.0	Yes	Ramp XSlope (%)	0.5
N/A	Flare Type LT	N/A	N/A	Flare Type RT	N/A
N/A	Flare Slope LT (%)	N/A	N/A	Flare Slope RT (%)	N/A
N/A	Flare Traversable LT?	N/A	N/A	Flare Traversable RT?	N/A
N/A	Landing Length (in)	N/A	N/A	DWS Provided?	N/A
N/A	Landing Width (in)	N/A	N/A	DWS Contrast?	N/A
N/A	Landing Slope (%)	N/A	N/A	DWS Length (in)	N/A
N/A	Landing X Slope (%)	N/A	N/A	DWS Full Width?	N/A
N/A	Landing Curb? (Y/N)	N/A	N/A	DWS Offset (in)	N/A
N/A	Shared Landing?	N/A			
N/A	Gutter Ponding?	N/A	N/A	Gutter Slope (%)	N/A
N/A	Gutter Lip Ht (in)	N/A	N/A	Gutter X Slope (%)	N/A
N/A	Painted X Walk1?	No	N/A	Painted X Walk2?	N/A
	X Walk 1 Direction	To SW		X Walk 2 Direction	N/A
N/A	X Walk 1 Width (in)	N/A	N/A	X Walk 2 Width (in)	N/A
	X Walk 1 Slope (%)	0.6		X Walk 2 Slope (%)	N/A
	X Walk 1 X Slope (%)	2.5		X Walk 2 X Slope (%)	N/A

N/A	Ramp inside XWalk1?	N/A	N/A	Ramp inside XWalk2?	N/A
	Road Slope (%)	N/A	N/A	Clear Space?	N/A
	Road X Slope (%)	N/A	N/A	Clear Space to XWalk (in)	N/A
N/A	Any Obstructions?	N/A	N/A	Storm Grate/Utility Hazard?	N/A
	Obstruction Type			Storm Grate/Utility Type	
		N/A			N/A
			Yes	Surface Condition? (G/P)	Good

**Remove & Replace Entire Ramp.**
