Access Compliance Report

Public Rights-of-Way

(Curb Ramps)

Intersection ID: 12089	Main Street: E_12TH_ST	Cross Street: N_DAVIDSON_ST	Location: N
ADA ID: 7F0E896B8B4C	Ramp Type: PerpDiag	Initial Pass/Fail: Fail	Overall Compliance: No
Severity Score: 46.25			
Codes/Mitigation Info/Possible Solution		Field Measurements/Component Compliance

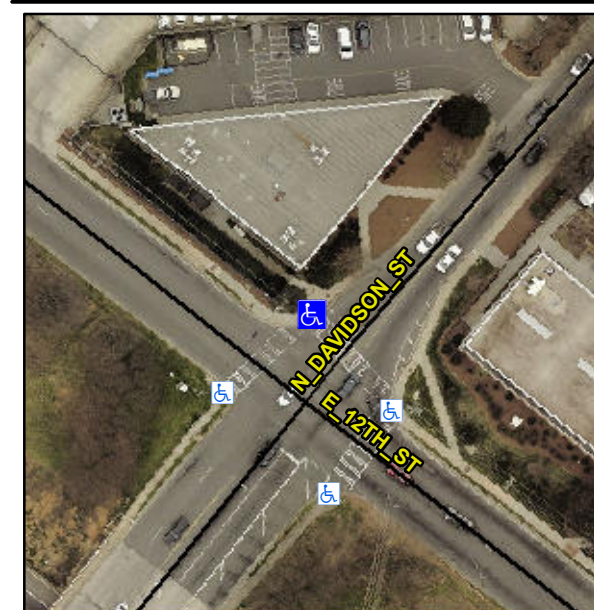
Not Found, R304.5.1, R304.2.2, R304.5.3

Compliance	Description	Data	Compliance	Description	Data
N/A	Ramp Length (in)	61.0	No	Ramp Slope (%)	13.2
No	Ramp Width (in)	47.0	No	Ramp XSlope (%)	5.9
N/A	Flare Type LT	N/A	N/A	Flare Type RT	N/A
N/A	Flare Slope LT (%)	N/A	N/A	Flare Slope RT (%)	N/A
N/A	Flare Traversable LT?	N/A	N/A	Flare Traversable RT?	N/A
N/A	Landing Length (in)	N/A	N/A	DWS Provided?	N/A
N/A	Landing Width (in)	N/A	N/A	DWS Contrast?	N/A
N/A	Landing Slope (%)	N/A	N/A	DWS Length (in)	N/A
N/A	Landing X Slope (%)	N/A	N/A	DWS Full Width?	N/A
N/A	Landing Curb? (Y/N)	N/A	N/A	DWS Offset (in)	N/A
N/A	Shared Landing?	N/A			
N/A	Gutter Ponding?	N/A	N/A	Gutter Slope (%)	N/A
N/A	Gutter Lip Ht (in)	3.0	N/A	Gutter X Slope (%)	N/A
N/A	Painted X Walk1?	Yes	N/A	Painted X Walk2?	Yes
	X Walk 1 Direction	To SW		X Walk 2 Direction	To SE
N/A	X Walk 1 Width (in)	143.0	N/A	X Walk 2 Width (in)	112.0
	X Walk 1 Slope (%)	2.3		X Walk 2 Slope (%)	6.4
	X Walk 1 X Slope (%)	8.3		X Walk 2 X Slope (%)	3.5

N/A	Ramp inside XWalk1?	Yes	N/A	Ramp inside XWalk2?	Yes
	Road Slope (%)	7.7	N/A	Clear Space?	N/A
	Road X Slope (%)	1.8	N/A	Clear Space to XWalk (in)	N/A
N/A	Any Obstructions?	N/A	N/A	Storm Grate/Utility Hazard?	N/A
	Obstruction Type			Storm Grate/Utility Type	
		N/A			N/A
		Yes		Surface Condition? (G/P)	Good

Remove & Replace Curb Ramp With Two New Directional Ramps or Equivalent.
