Access Compliance Report

Public Rights-of-Way

(Curb Ramps)

Intersection ID: 2778	Main Street: HIGHLAND_CREEK_PY	Cross Street: BRADWELL_DR	Location: E
ADA ID: 7F13E6AEB9FF	Ramp Type: PerpDiag	Initial Pass/Fail: Fail	Overall Compliance: No
Severity Score: 33.75			
Codes/Mitigation Info/Possible Solution		Field Measurements/Component Compliance

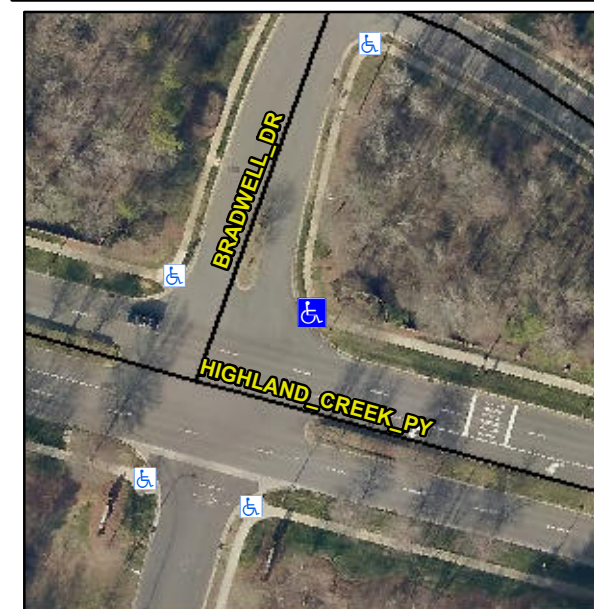
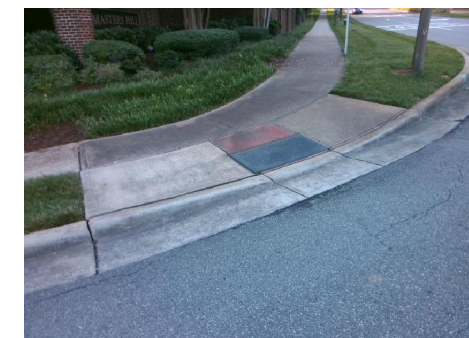
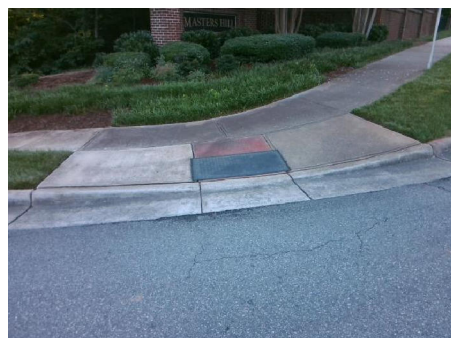
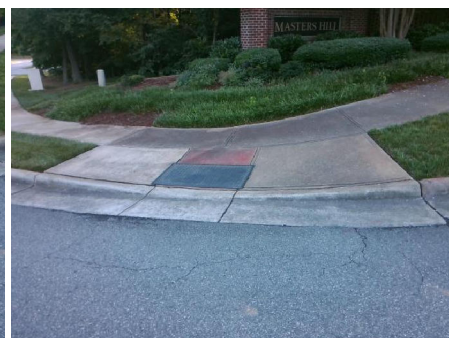
Compliance	Description	Data	Compliance	Description	Data
N/A	Ramp Length (in)	50.5	No	Ramp Slope (%)	10.3
No	Ramp Width (in)	43.5	No	Ramp XSlope (%)	6.6
N/A	Flare Type LT	N/A	N/A	Flare Type RT	N/A
N/A	Flare Slope LT (%)	N/A	N/A	Flare Slope RT (%)	N/A
N/A	Flare Traversable LT?	N/A	N/A	Flare Traversable RT?	N/A
N/A	Landing Length (in)	N/A	N/A	DWS Provided?	N/A
N/A	Landing Width (in)	N/A	N/A	DWS Contrast?	N/A
N/A	Landing Slope (%)	N/A	N/A	DWS Length (in)	N/A
N/A	Landing X Slope (%)	N/A	N/A	DWS Full Width?	N/A
N/A	Landing Curb? (Y/N)	N/A	N/A	DWS Offset (in)	N/A
N/A	Shared Landing?	N/A			
N/A	Gutter Ponding?	N/A	N/A	Gutter Slope (%)	N/A
N/A	Gutter Lip Ht (in)	N/A	N/A	Gutter X Slope (%)	N/A
N/A	Painted X Walk1?	No	N/A	Painted X Walk2?	No
	X Walk 1 Direction	To NW		X Walk 2 Direction	To SW
N/A	X Walk 1 Width (in)	N/A	N/A	X Walk 2 Width (in)	N/A
	X Walk 1 Slope (%)	1.5		X Walk 2 Slope (%)	8.4
	X Walk 1 X Slope (%)	7.2		X Walk 2 X Slope (%)	3.3

N/A	Ramp inside XWalk1?	N/A	N/A	Ramp inside XWalk2?	N/A
	Road Slope (%)	6.2	N/A	Clear Space?	N/A
	Road X Slope (%)	6.9	N/A	Clear Space to XWalk (in)	N/A
N/A	Any Obstructions?	N/A	N/A	Storm Grate/Utility Hazard?	N/A
	Obstruction Type			Storm Grate/Utility Type	
		N/A			N/A
			Yes	Surface Condition? (G/P)	Good

Possible Solutions:

Remove & Replace Curb Ramp With Two New Directional Ramps or Equivalent.
