Access Compliance Report

Public Rights-of-Way

(Curb Ramps)

Intersection ID: 11201	Main Street: BRIARHILL_DR	Cross Street: MEADOWCLIFF_DR	Location:	N
ADA ID: 7F13FB8F1D55	Ramp Type: BlendTrans1	Initial Pass/Fail: Fail	Overall Compliance: No	Severity Score: 10

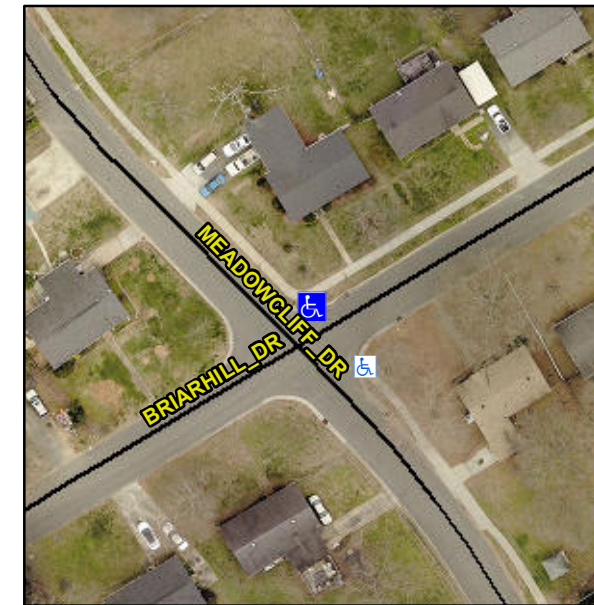
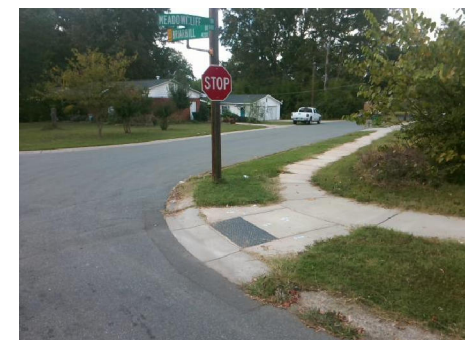
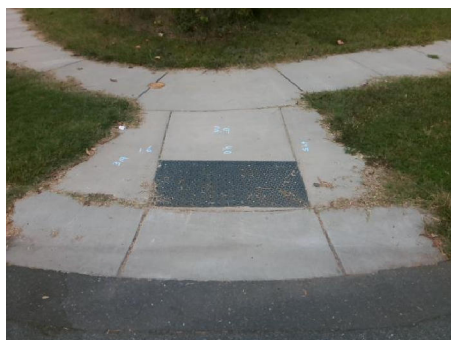
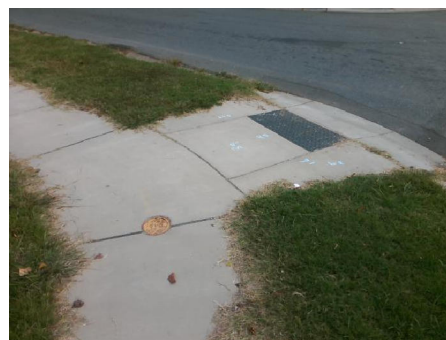
Not Found, R304.5.1, R304.5.3

Compliance	Description	Data	Compliance	Description	Data
N/A	Ramp Length (in)	64.5	Yes	BlendTrans Slope (%)	4.0
No	Ramp Width (in)	47.0	No	BlendTrans XSlope (%)	3.9
N/A	Flare Type LT	N/A	N/A	Flare Type RT	N/A
N/A	Flare Slope LT (%)	N/A	N/A	Flare Slope RT (%)	N/A
N/A	Flare Traversable LT?	N/A	N/A	Flare Traversable RT?	N/A
N/A	Landing Length (in)	N/A	N/A	DWS Provided?	N/A
N/A	Landing Width (in)	N/A	N/A	DWS Contrast?	N/A
N/A	Landing Slope (%)	N/A	N/A	DWS Length (in)	N/A
N/A	Landing X Slope (%)	N/A	N/A	DWS Full Width?	N/A
N/A	Landing Curb? (Y/N)	N/A	N/A	DWS Offset (in)	N/A
N/A	Shared Landing?	N/A			
N/A	Gutter Ponding?	N/A	N/A	Gutter Slope (%)	N/A
N/A	Gutter Lip Ht (in)	N/A	N/A	Gutter X Slope (%)	N/A
N/A	Painted X Walk1?	No	N/A	Painted X Walk2?	N/A
	X Walk 1 Direction	To SE		X Walk 2 Direction	N/A
	X Walk 1 Width (in)	N/A		X Walk 2 Width (in)	N/A
	X Walk 1 Slope (%)	3.9		X Walk 2 Slope (%)	N/A
	X Walk 1 X Slope (%)	1.6		X Walk 2 X Slope (%)	N/A

N/A	Ramp inside XWalk1?	N/A	N/A	Ramp inside XWalk2?	N/A
	Road Slope (%)	1.6		Clear Space?	N/A
	Road X Slope (%)	3.9	N/A	Clear Space to XWalk (in)	N/A
N/A	Any Obstructions?	N/A	N/A	Storm Grate/Utility Hazard?	N/A
	Obstruction Type			Storm Grate/Utility Type	
		N/A			N/A
			Yes	Surface Condition? (G/P)	Good
			No	Curb Slope (%)	10.7

Remove & Replace Curb Ramp With Two New Directional Ramps or Equivalent.
