Access Compliance Report Public Rights-of-Way (Curb Ramps)

Main Street: STEELE CREEK RD Cross Street: WALKER BRANCH DR Location: Intersection ID: 48863 NW Ramp Type: PerpDiag Initial Pass/Fail: Fail **Overall Compliance: No Severity Score:** 12.5 ADA ID: 7F1895FD4219

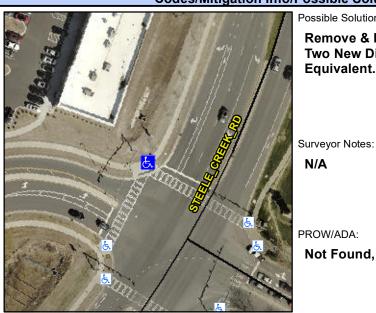
Not Found, R304.2.2

STEELECROFT PY Signal STEELE CREEK RD Possible Solutions: Remove & Replace Curb Ramp With Two New Directional Ramps or Equivalent.
