Access Compliance Report

Public Rights-of-Way

(Curb Ramps)

Intersection ID: 48955	Main Street: ROYA_PL	Cross Street: DAVID_JENNINGS_AV	Location: W
ADA ID: 7F1F59BAAD05	Ramp Type: Perp	Initial Pass/Fail: Pass	Overall Compliance: No
Severity Score: 5			
Codes/Mitigation Info/Possible Solution		Field Measurements/Component Compliance

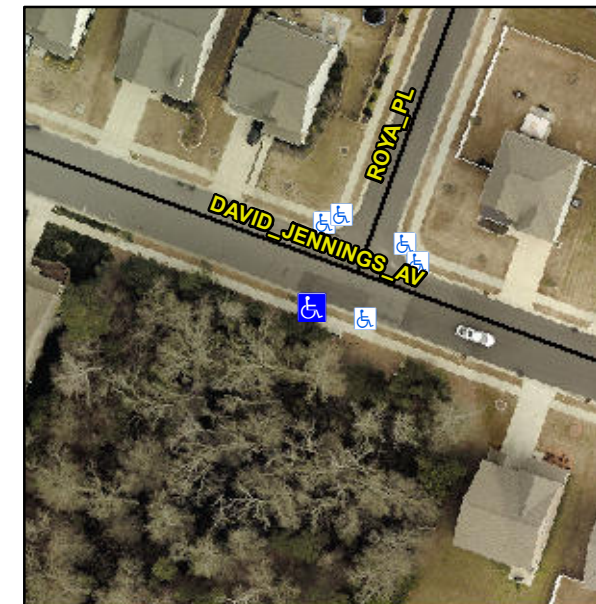
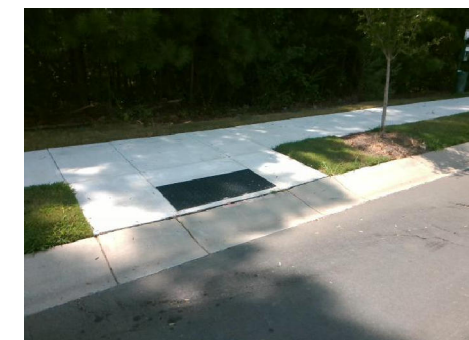
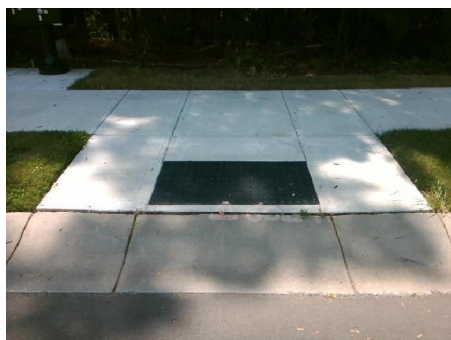
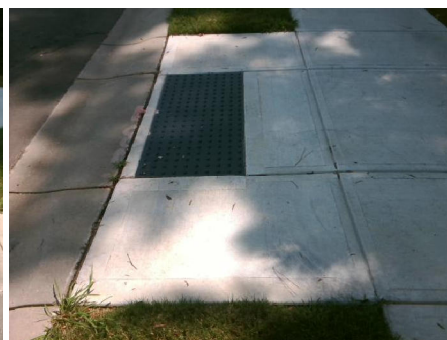
**Not Found, R305.2, R304.5.4,
R304.5.3**

Compliance	Description	Data	Compliance	Description	Data
N/A	Ramp Length (in)	46.5	Yes	Ramp Slope (%)	7.6
Yes	Ramp Width (in)	48.0	Yes	Ramp XSlope (%)	1.2
N/A	Flare Type LT	Sloped	N/A	Flare Type RT	N/A
N/A	Flare Slope LT (%)	2.3	N/A	Flare Slope RT (%)	7.2
N/A	Flare Traversable LT?	No	N/A	Flare Traversable RT?	No
Yes	Landing Length (in)	60.0	Yes	DWS Provided?	Yes
Yes	Landing Width (in)	48.0	Yes	DWS Contrast?	Yes
Yes	Landing Slope (%)	1.3	Yes	DWS Length (in)	24.0
Yes	Landing X Slope (%)	1.2	Yes	DWS Full Width?	Yes
N/A	Landing Curb? (Y/N)	No	No	DWS Offset (in)	3.0
N/A	Shared Landing?	No			
Yes	Gutter Ponding?	No	No	Gutter Slope (%)	7.6
Yes	Gutter Lip Ht (in)	0.0	No	Gutter X Slope (%)	3.6
N/A	Painted X Walk1?	No	N/A	Painted X Walk2?	N/A
	X Walk 1 Direction	To N		X Walk 2 Direction	N/A
N/A	X Walk 1 Width (in)	N/A	N/A	X Walk 2 Width (in)	N/A
	X Walk 1 Slope (%)	5.8		X Walk 2 Slope (%)	N/A
	X Walk 1 X Slope (%)	0.5		X Walk 2 X Slope (%)	N/A

N/A	Ramp inside XWalk1?	N/A	N/A	Ramp inside XWalk2?	N/A
	Road Slope (%)	N/A	N/A	Clear Space?	Yes
	Road X Slope (%)	N/A	N/A	Clear Space to XWalk (in)	N/A
Yes	Any Obstructions?	No	Yes	Storm Grate/Utility Hazard?	No
	Obstruction Type			Storm Grate/Utility Type	
		N/A			N/A
			Yes	Surface Condition? (G/P)	Good

Possible Solutions:

**Remove & Replace Entire Ramp.
Remove & Replace Gutter.**
