Access Compliance Report

Public Rights-of-Way

(Curb Ramps)

Intersection ID: 22684	Main Street: OUTER_BRIDGE_LN	Cross Street: OXWYNN_LN	Location: NE
ADA ID: 7F2123C2FADE	Ramp Type: PerpDiag	Initial Pass/Fail: Fail	Overall Compliance: No
Severity Score: 50			
Codes/Mitigation Info/Possible Solution		Field Measurements/Component Compliance

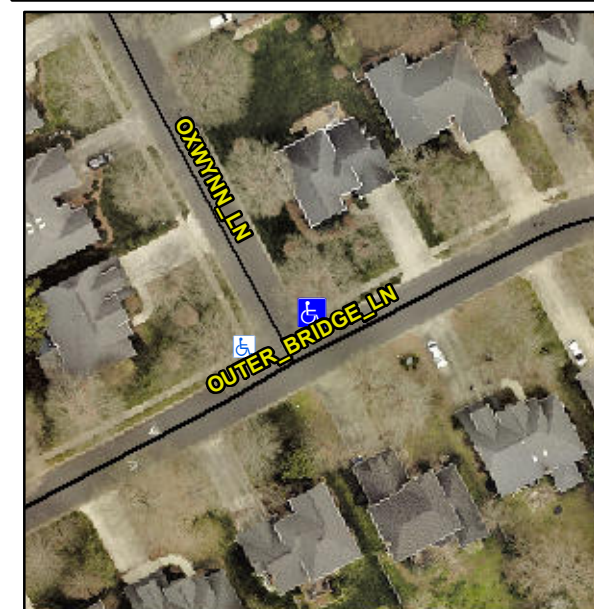
Compliance	Description	Data	Compliance	Description	Data
N/A	Ramp Length (in)	49.0	No	Ramp Slope (%)	12.6
Yes	Ramp Width (in)	48.0	No	Ramp XSlope (%)	7.1
N/A	Flare Type LT	N/A	N/A	Flare Type RT	N/A
N/A	Flare Slope LT (%)	N/A	N/A	Flare Slope RT (%)	N/A
N/A	Flare Traversable LT?	N/A	N/A	Flare Traversable RT?	N/A
N/A	Landing Length (in)	N/A	N/A	DWS Provided?	N/A
N/A	Landing Width (in)	N/A	N/A	DWS Contrast?	N/A
N/A	Landing Slope (%)	N/A	N/A	DWS Length (in)	N/A
N/A	Landing X Slope (%)	N/A	N/A	DWS Full Width?	N/A
N/A	Landing Curb? (Y/N)	N/A	N/A	DWS Offset (in)	N/A
N/A	Shared Landing?	N/A			
N/A	Gutter Ponding?	N/A	N/A	Gutter Slope (%)	N/A
N/A	Gutter Lip Ht (in)	N/A	N/A	Gutter X Slope (%)	N/A
N/A	Painted X Walk1?	No	N/A	Painted X Walk2?	No
	X Walk 1 Direction	To W		X Walk 2 Direction	To S
N/A	X Walk 1 Width (in)	N/A	N/A	X Walk 2 Width (in)	N/A
	X Walk 1 Slope (%)	1.2		X Walk 2 Slope (%)	3.6
	X Walk 1 X Slope (%)	5.1		X Walk 2 X Slope (%)	2.4

N/A	Ramp inside XWalk1?	N/A	N/A	Ramp inside XWalk2?	N/A
	Road Slope (%)	6.7	N/A	Clear Space?	N/A
	Road X Slope (%)	2.0	N/A	Clear Space to XWalk (in)	N/A
N/A	Any Obstructions?	N/A	N/A	Storm Grate/Utility Hazard?	N/A
	Obstruction Type			Storm Grate/Utility Type	
		N/A			N/A
		Yes		Surface Condition? (G/P)	Good

Possible Solutions:

Remove & Replace Curb Ramp With Two New Directional Ramps or Equivalent.

R304.2.2, R304.5.3
