# Access Compliance Report

## Public Rights-of-Way

Intersection ID: 30347	Main Street: GOLD_PAN_RD	Cross Street: SLICKROCK_CR	Location: SE
ADA ID: 7F2EEC47DBA2	Ramp Type: PerpDiag	Initial Pass/Fail: Fail	Overall Compliance: No
		Severity Score: 42.5

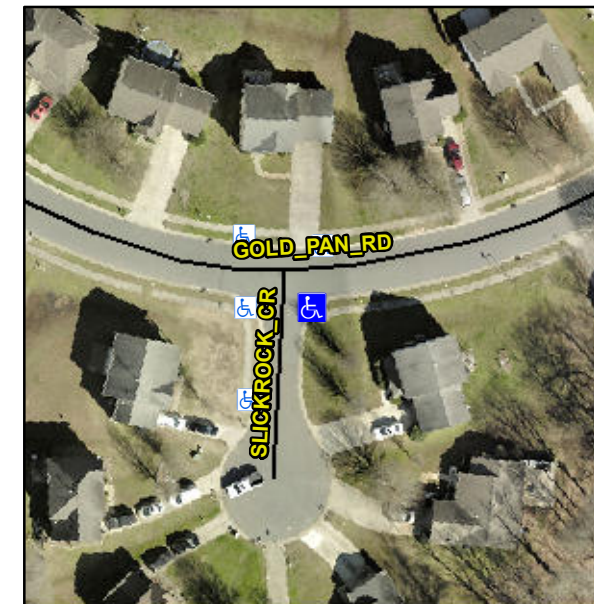
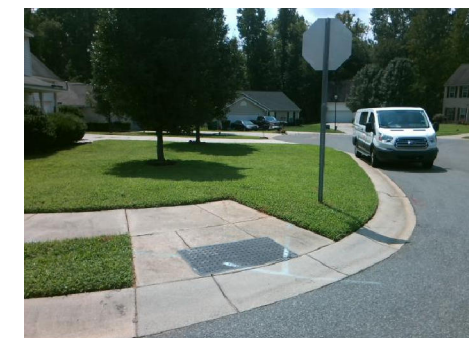
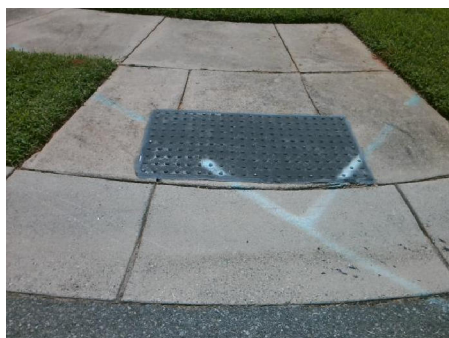
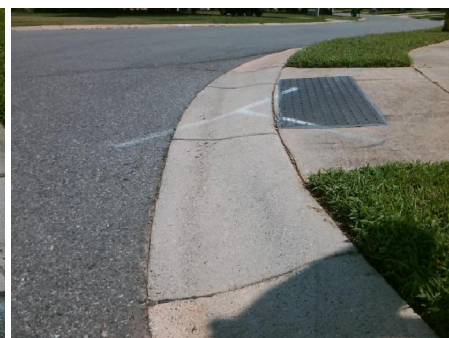
**Not Found, R304.5.1, R304.5.3**

Compliance	Description	Data	Compliance	Description	Data
N/A	Ramp Length (in)	49.5	Yes	Ramp Slope (%)	7.4
No	Ramp Width (in)	33.5	No	Ramp XSlope (%)	7.4
N/A	Flare Type LT	N/A	N/A	Flare Type RT	N/A
N/A	Flare Slope LT (%)	N/A	N/A	Flare Slope RT (%)	N/A
N/A	Flare Traversable LT?	N/A	N/A	Flare Traversable RT?	N/A
N/A	Landing Length (in)	N/A	N/A	DWS Provided?	N/A
N/A	Landing Width (in)	N/A	N/A	DWS Contrast?	N/A
N/A	Landing Slope (%)	N/A	N/A	DWS Length (in)	N/A
N/A	Landing X Slope (%)	N/A	N/A	DWS Full Width?	N/A
N/A	Landing Curb? (Y/N)	N/A	N/A	DWS Offset (in)	N/A
N/A	Shared Landing?	N/A			
N/A	Gutter Ponding?	N/A	N/A	Gutter Slope (%)	N/A
N/A	Gutter Lip Ht (in)	N/A	N/A	Gutter X Slope (%)	N/A
N/A	Painted X Walk1?	No	N/A	Painted X Walk2?	No
	X Walk 1 Direction	To N		X Walk 2 Direction	To W
N/A	X Walk 1 Width (in)	N/A	N/A	X Walk 2 Width (in)	N/A
	X Walk 1 Slope (%)	7.3		X Walk 2 Slope (%)	2.6
	X Walk 1 X Slope (%)	3.5		X Walk 2 X Slope (%)	6.9

N/A	Ramp inside XWalk1?	N/A	N/A	Ramp inside XWalk2?	N/A
	Road Slope (%)	2.6	N/A	Clear Space?	N/A
	Road X Slope (%)	7.0	N/A	Clear Space to XWalk (in)	N/A
N/A	Any Obstructions?	N/A	N/A	Storm Grate/Utility Hazard?	N/A
	Obstruction Type			Storm Grate/Utility Type	
		N/A			N/A
			Yes	Surface Condition? (G/P)	Good

**Remove & Replace Curb Ramp With Two New Directional Ramps or Equivalent.**
